# Drinking Water Management System Annual Report 2021/22

**Goldenfields Water County Council**

**Date: October 2022**

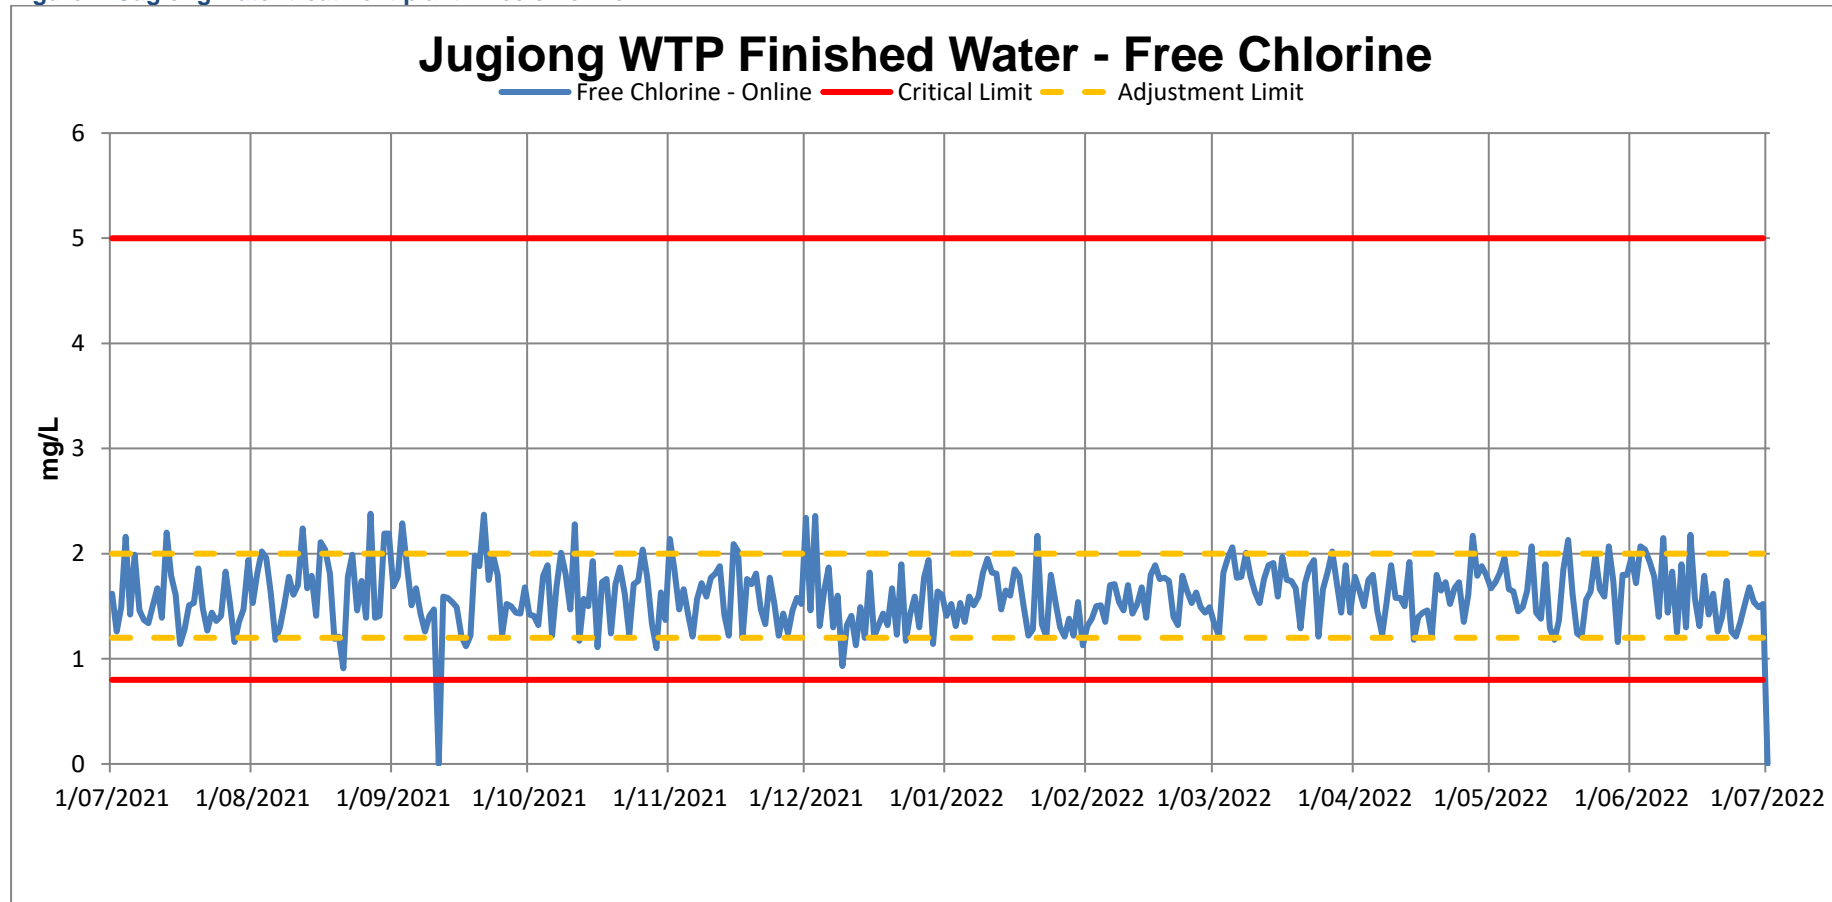
Figure 1. Jugiong water treatment plant - free chlorine.

Figure 1 above is a representation of Free Chlorine in the water leaving the Jugiong Water Treatment Plant. The red lines are our Critical Control Points (CCP) for the concentration of chlorine in the water and the orange lines are our Operational control points. As is indicated above, GWCC is consistently within the CCP throughout the year with the exception of 1 exceedance. This exceedance is explained in Table 3 above as failed instrumentation.

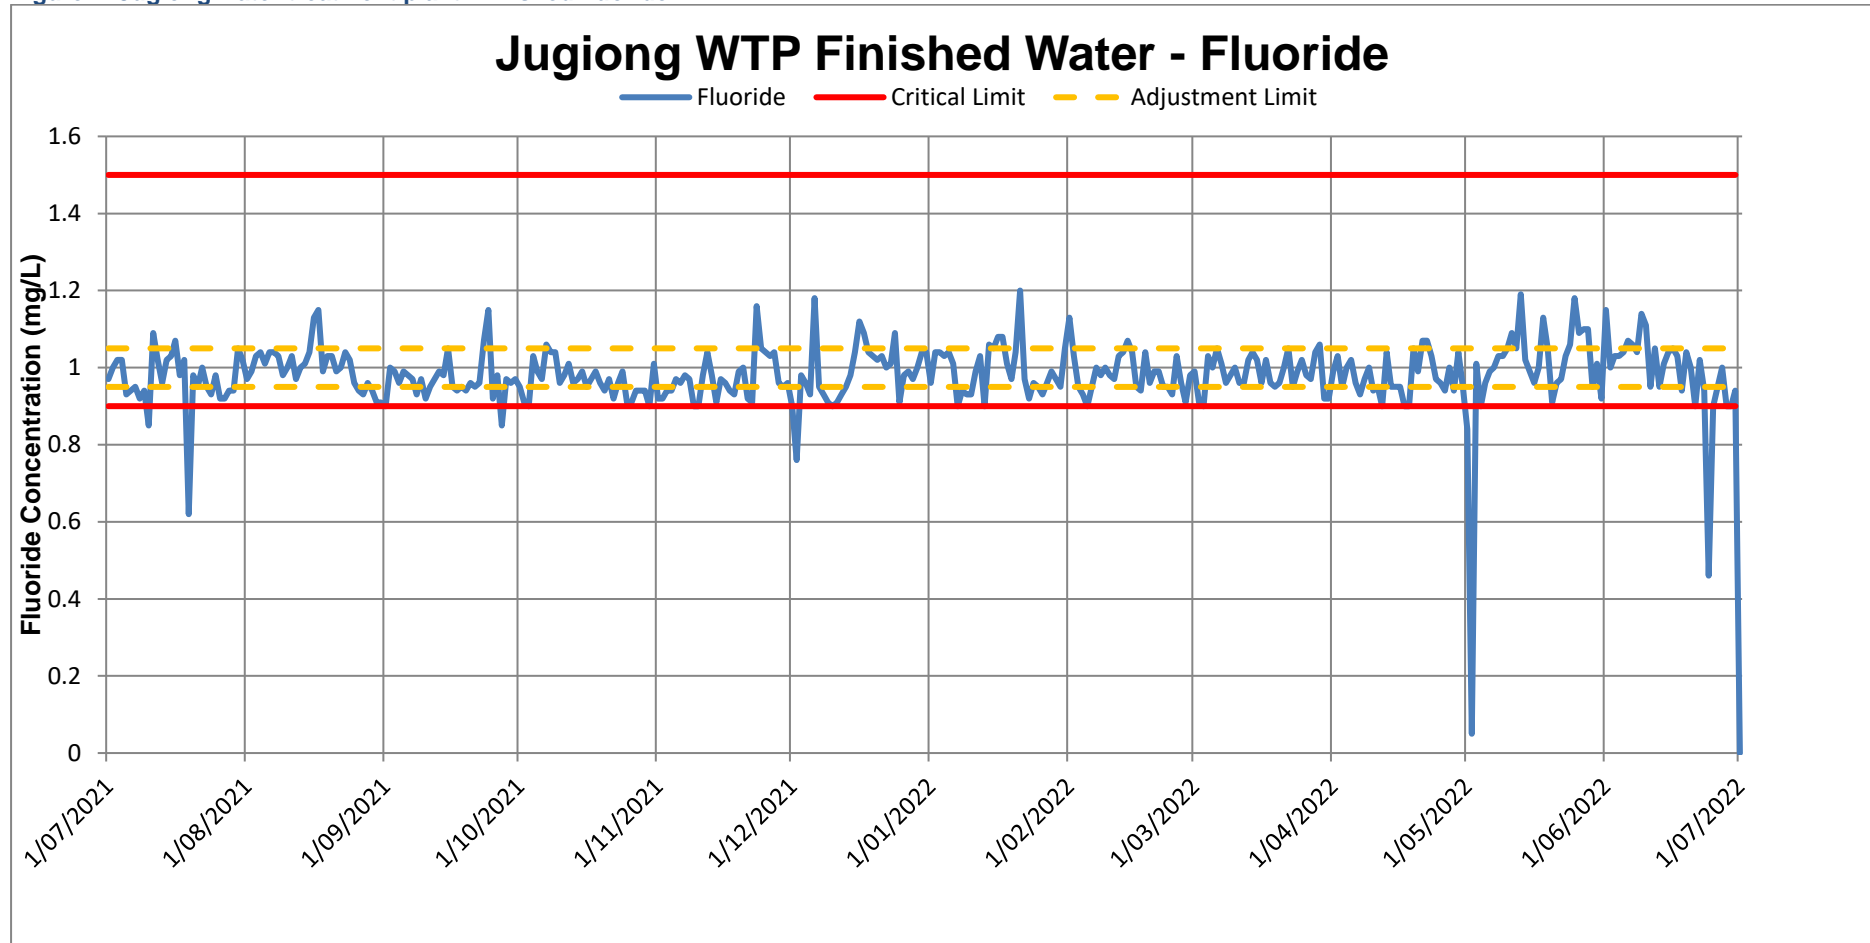
Figure 2. Jugiong water treatment plant - finished fluoride.

Figure 2 is a representation of the Finished Water Fluoride in the water leaving the Jugiong Water Treatment Plant. The red lines are our Critical Control Points (CCP) limits for the concentration of Fluoride in the water and the orange lines are our Operational control points. As is indicated above, GWCC is generally within the CCP throughout the year with the exception of 7 exceedances as indicated above. These exceedances are explained in Table 3 above, Critical Limit exceedances. Fluoride dosing equipment has been recently audited by Atom Consulting in 2020 with an estimated price for replacement of equipment to be \$190,000.

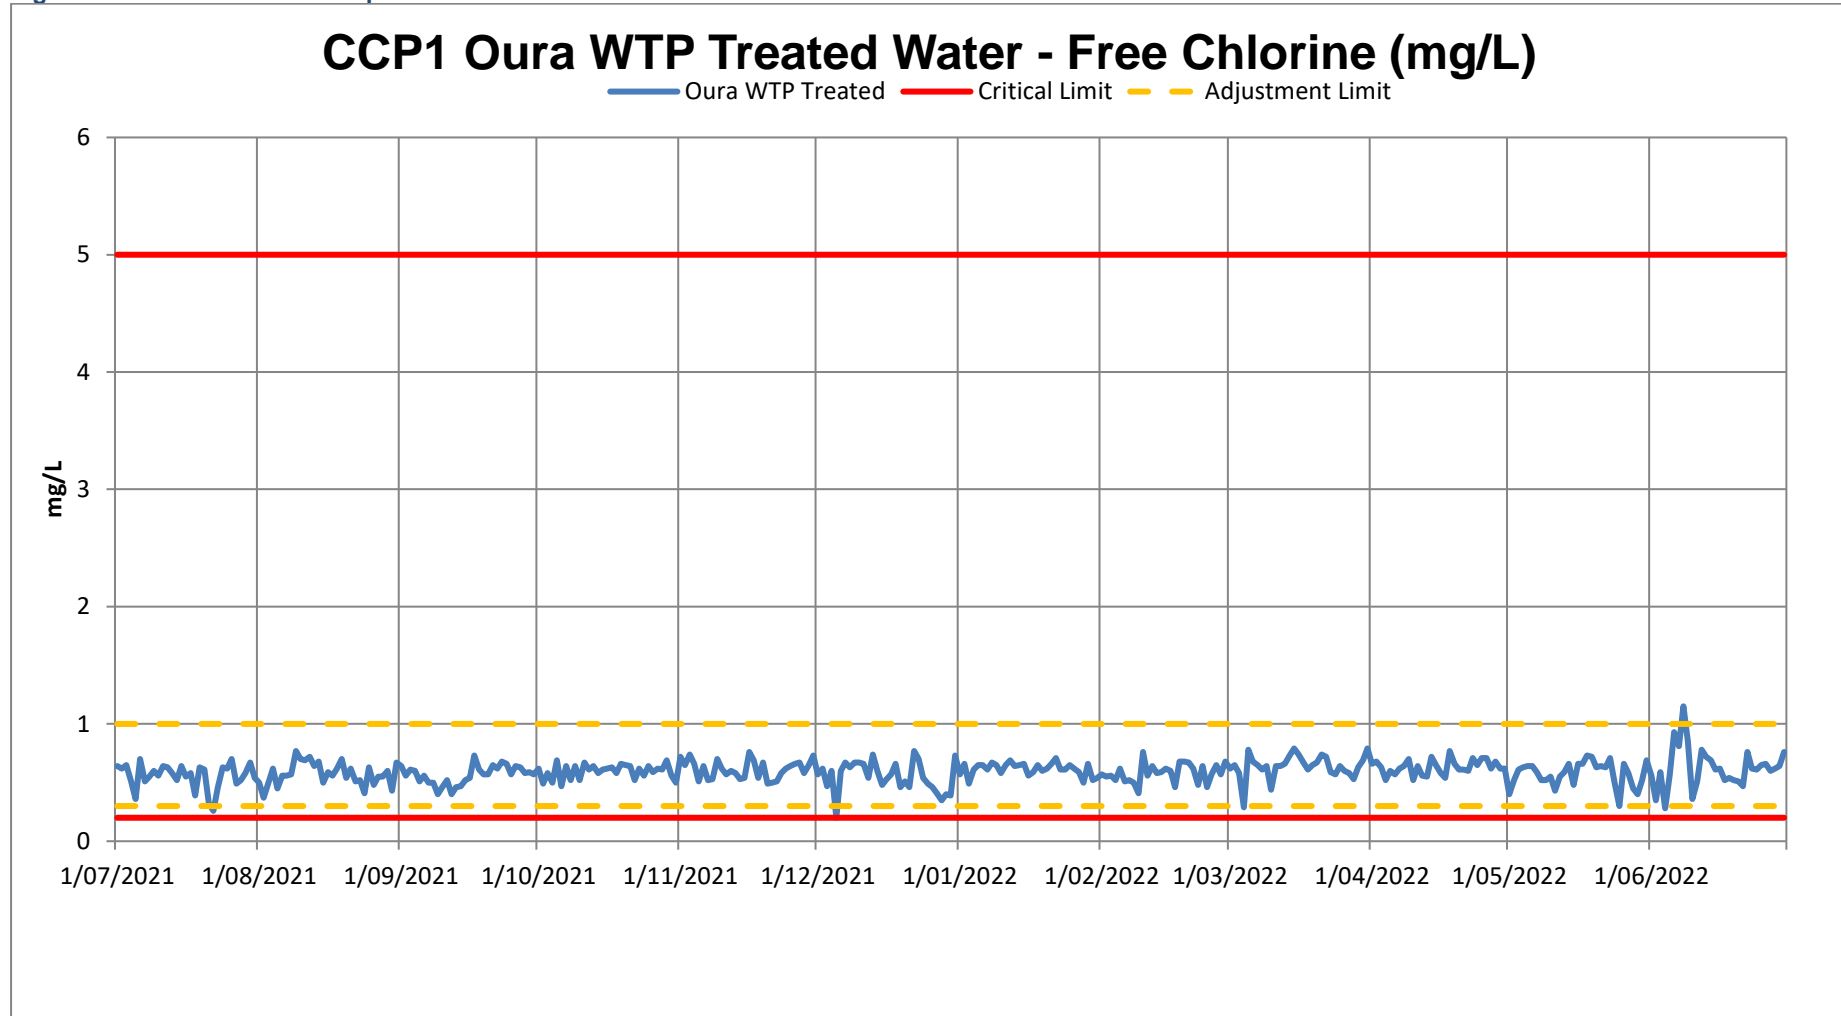
Figure 3. Oura water treatment plant - finished water free chlorine.

Figure 3 above is a representation of Free Chlorine in the water leaving the Oura Water Treatment Plant which employs a logarithmic scale on vertical axis. The red lines are our Critical Control Points (CCP) for the concentration of chlorine in the water and the orange lines are our Operational control points. As is indicated above, GWCC is consistently within the CCP throughout the year with no exceedances.

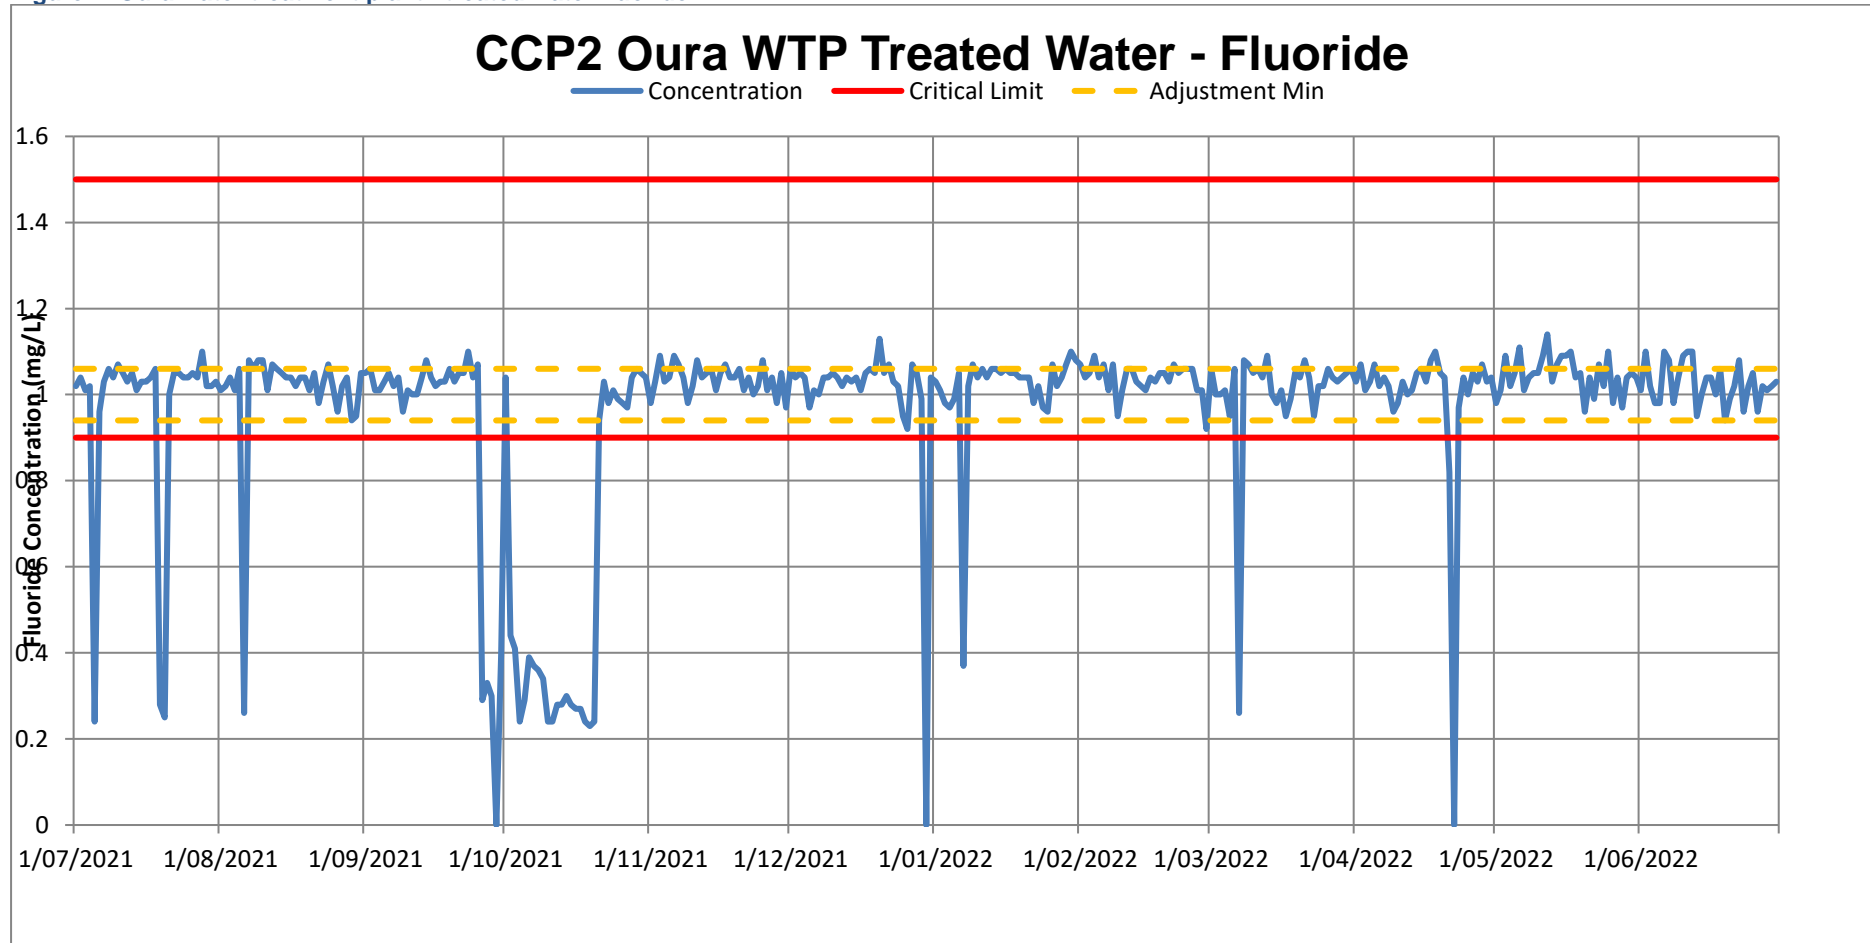
Figure 4. Oura water treatment plant - treated water fluoride.

Figure 4 above is a representation of the Finished Water Fluoride in the water leaving the Oura Water Treatment Plant. The red lines are our Critical Control Points (CCP) limits for the concentration of Fluoride in the water and the orange lines are our Operational control points. As is indicated above, there has been multiple exceedances throughout the reporting period, these exceedances have been explained in table 4 above. New Fluoride assets are recommended by GWCC and will be considered for replacement in 2024 in conjunction with the development of a new pump station and dosing facility.

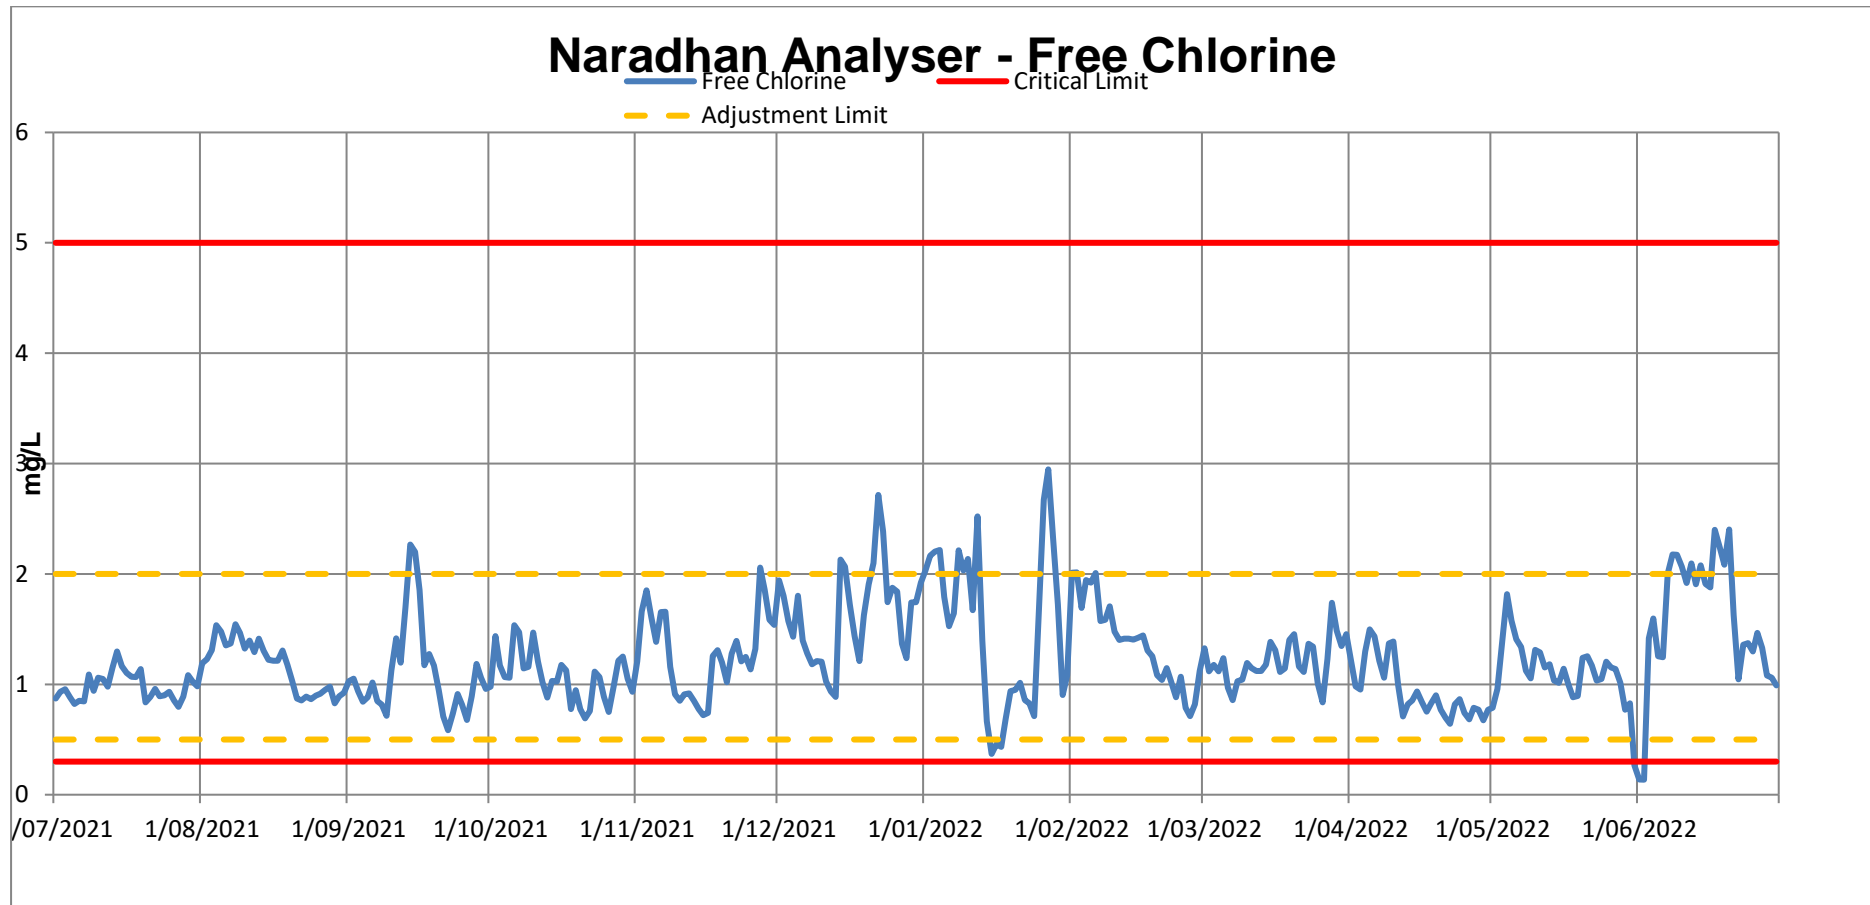
Figure 5: Mt Daylight finished water Free Chlorine

Figure 5 above is representative of the finished water Free Chlorine for the Mt Daylight system. The red lines are our CCPs and the orange lines are the operational limits. It has been a very consistent throughout the year, however, there were three exceedances reported due to failed calibrations.

These exceedances have been explained in table 5 above.

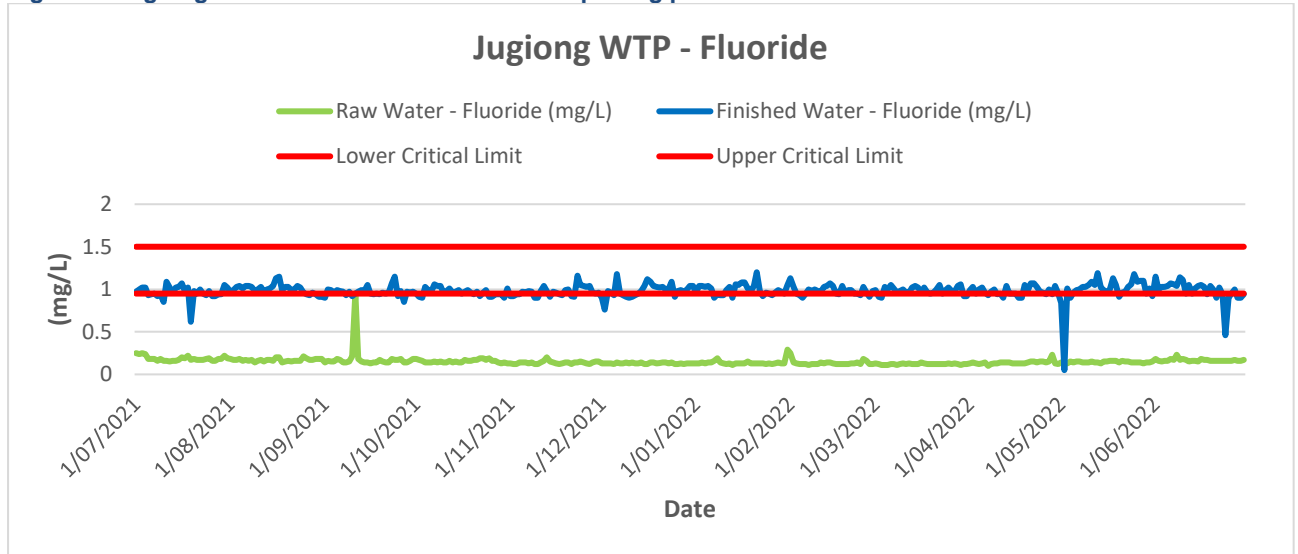
**Figure 6. Jugiong fluoride levels for the 2021/22 reporting period**

Figure 5 represents the finished water fluoride (Blue line) and Raw Water Fluoride (Green Line) for the Jugiong water treatment plant. Fluoride levels both Raw and Finished has remained consistent throughout the reporting period with a minimum value of 0.15 mg/L (Raw Water concentration) and a maximum value of 1.15 mg/L (Finished water Concentration). The Finished water Fluoride at the Jugiong Water Treatment Plant has exceeded its minimum value of 0.95mg/L on several occasions throughout the reporting period. These exceedances were due to equipment failure or breakdown.

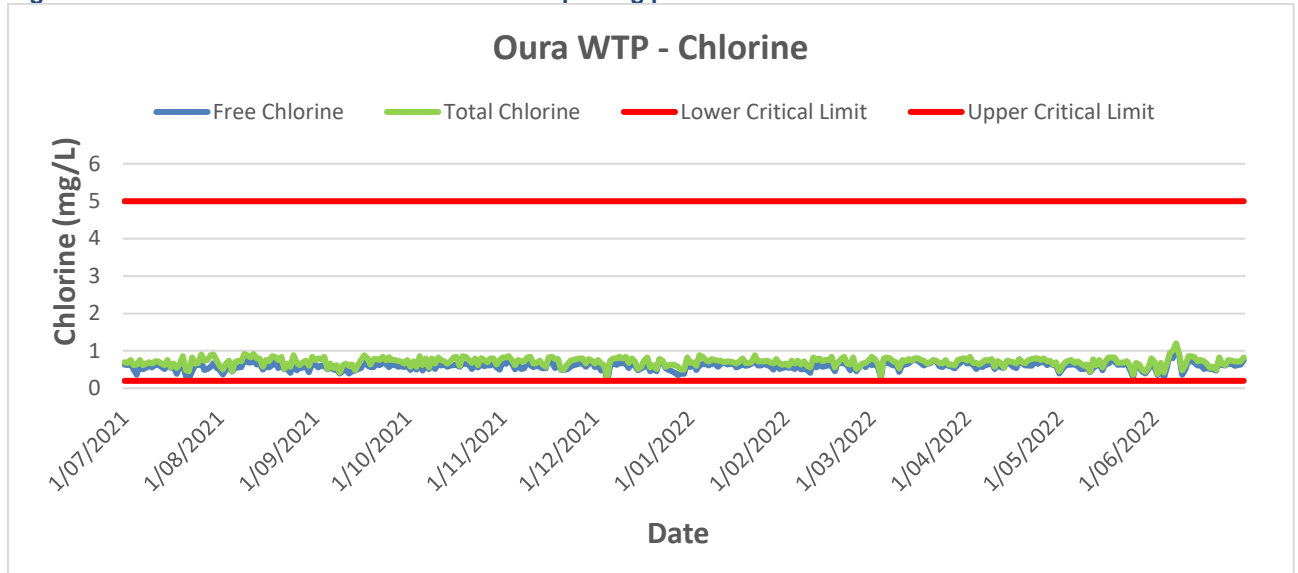
Figure 10. Oura chlorine levels for the 2021/22 reporting period

As can be seen in Figure 10, which uses a logarithmic scale on the vertical axis, the injection of chlorine into the Oura bore water has been extremely consistent throughout the reporting period. Averaging approx. 0.59mg/L (FCI) and 0.71mg/L (TCI) for the 12 months this is slightly higher than our target of 0.5mg/L but well within our CCP range of 0.2mg/L and 5mg/L. Overall a very good result for the Oura WTP operations.

There were no exceedances for chlorine dosing in the 2021/22 financial year.

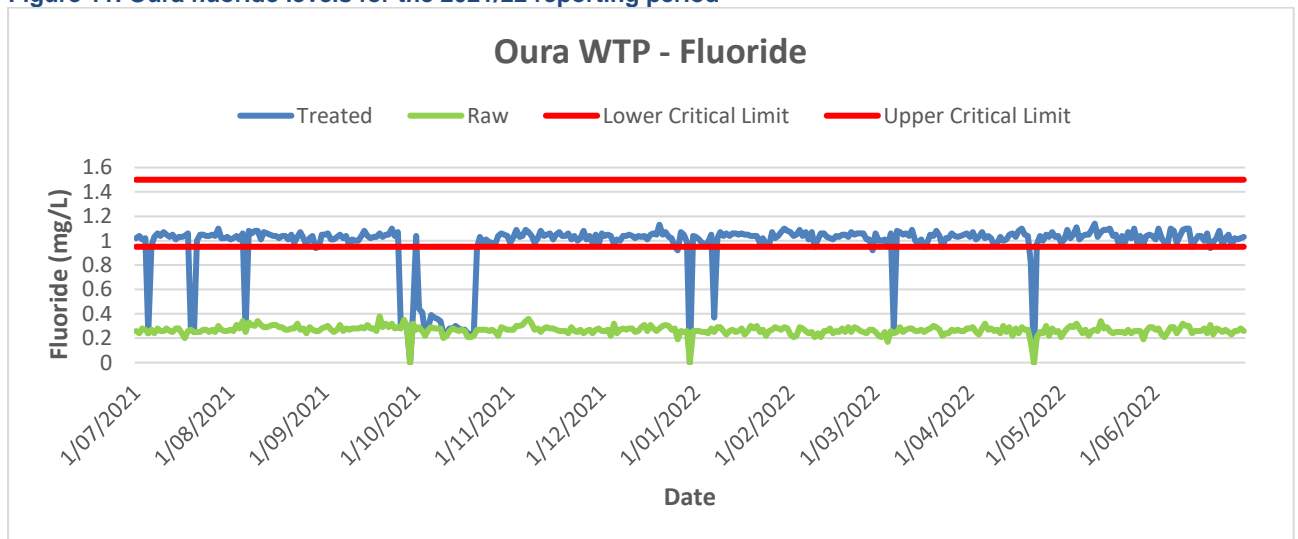
Figure 11. Oura fluoride levels for the 2021/22 reporting period

As can be seen in Figure 11, the raw fluoride content from the Oura Bores is very consistent remaining mostly between 0.2mg/L and 0.4mg/L for the reporting period 2021/22. Raw water fluoride averaged 0.17mg/L for the 2021/22 period.

The treated water fluoride was fairly inconsistent over the reporting period recording several exceedances. **All exceedances may be attributed to equipment failure.**

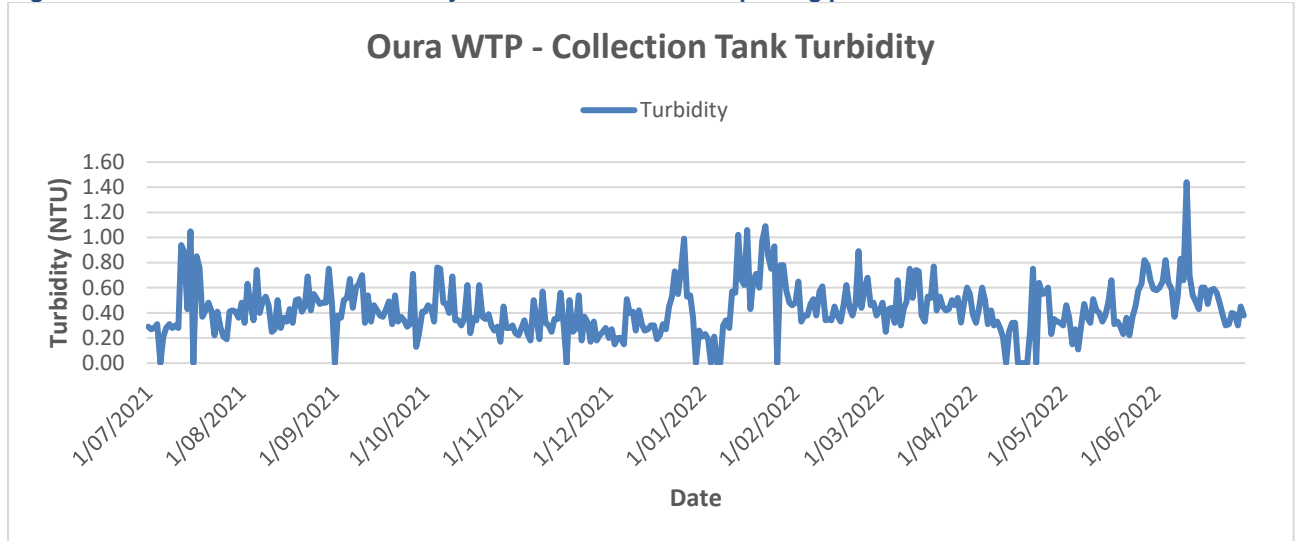
Figure 12. Oura collection tank turbidity levels for the 2021/22 reporting period

Figure 12 shows the turbidity at the Oura collection tank. Australian Drinking Water Guidelines (ADWG) indicates that turbidity should be <5 NTU (Nephelometric Turbidity Units). As can be seen, there have been no exceedances of this limit for the 2021/22 reporting period.
