# Drinking Water Management System

## Annual Report 2020/21

**Goldenfields Water County Council**

**Date: October 2021**

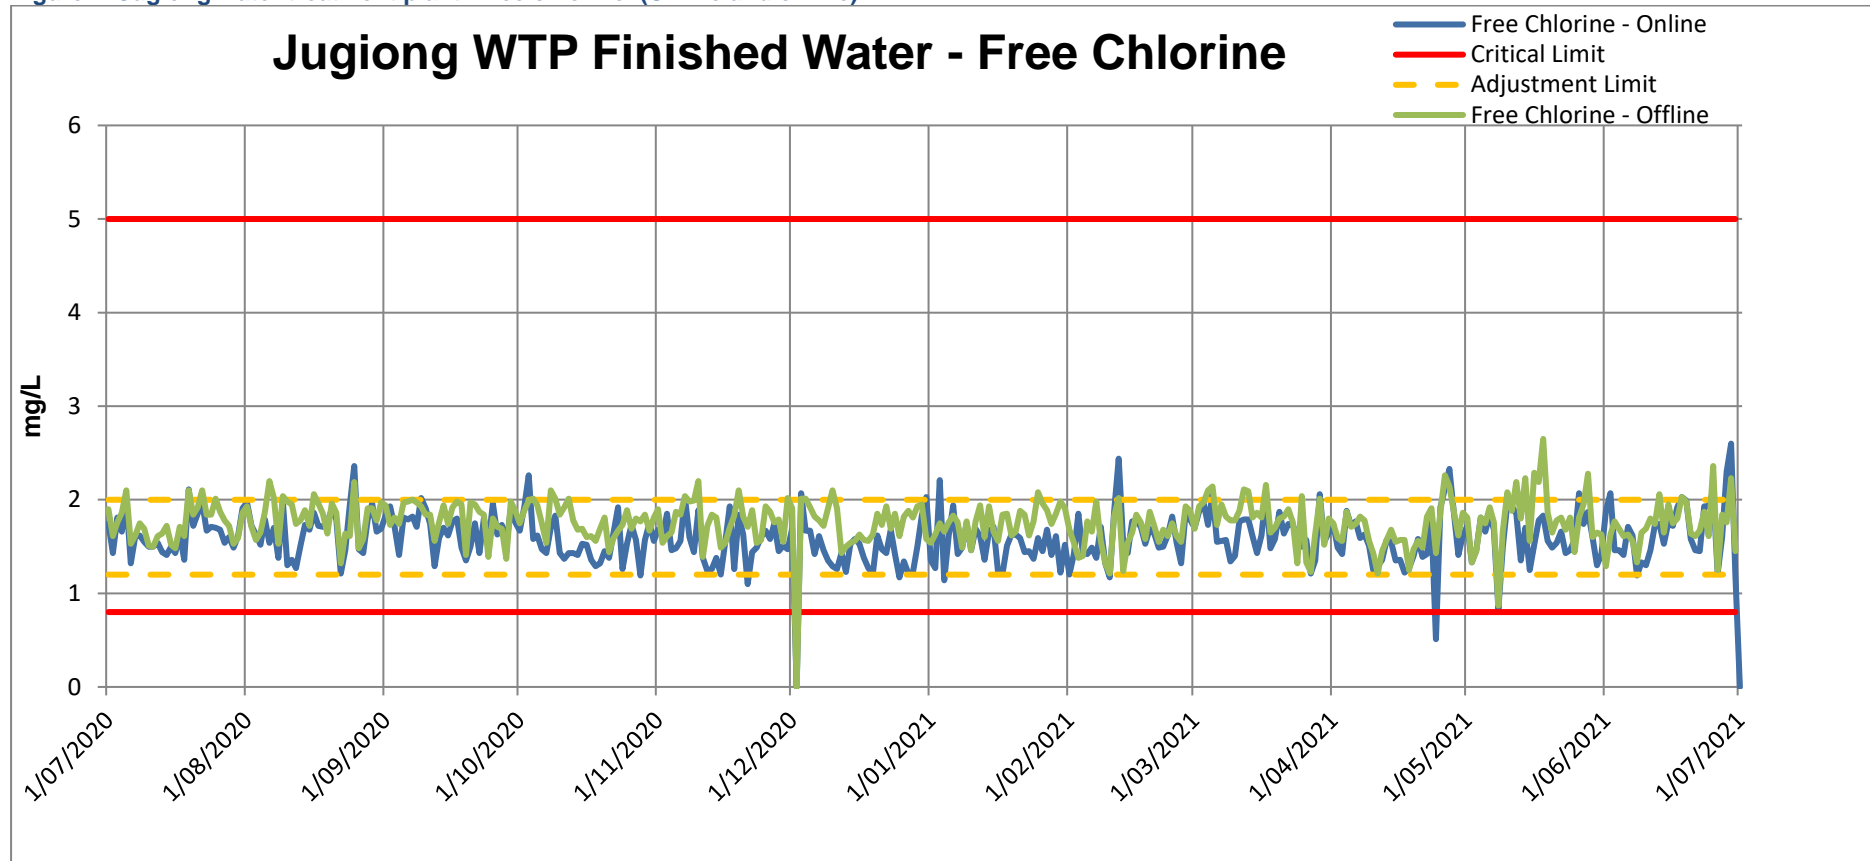
Figure 1. Jugiong water treatment plant - free chlorine. (Online and offline)

Figure 1 above is a representation of Free Chlorine in the water leaving the Jugiong Water Treatment Plant. The red lines are our Critical Control Points (CCP) for the concentration of chlorine in the water and the orange lines are our Operational control points. As is indicated above, GWCC is consistently within the CCP throughout the year except for 2 exceedances. These exceedances are explained in Table 3 above, Critical Limit exceedances. Note: no pumping occurred on 2/12/2020 due to a power outage. This would equate for the lower limit exceedance on the 2<sup>nd</sup> of December 2020. The green line represents the offline testing that is undertaken manually by the Water treatment plant operators. These tests are conducted for quality assurance and to make sure the online chlorine analyser is working correctly and within calibration limits.

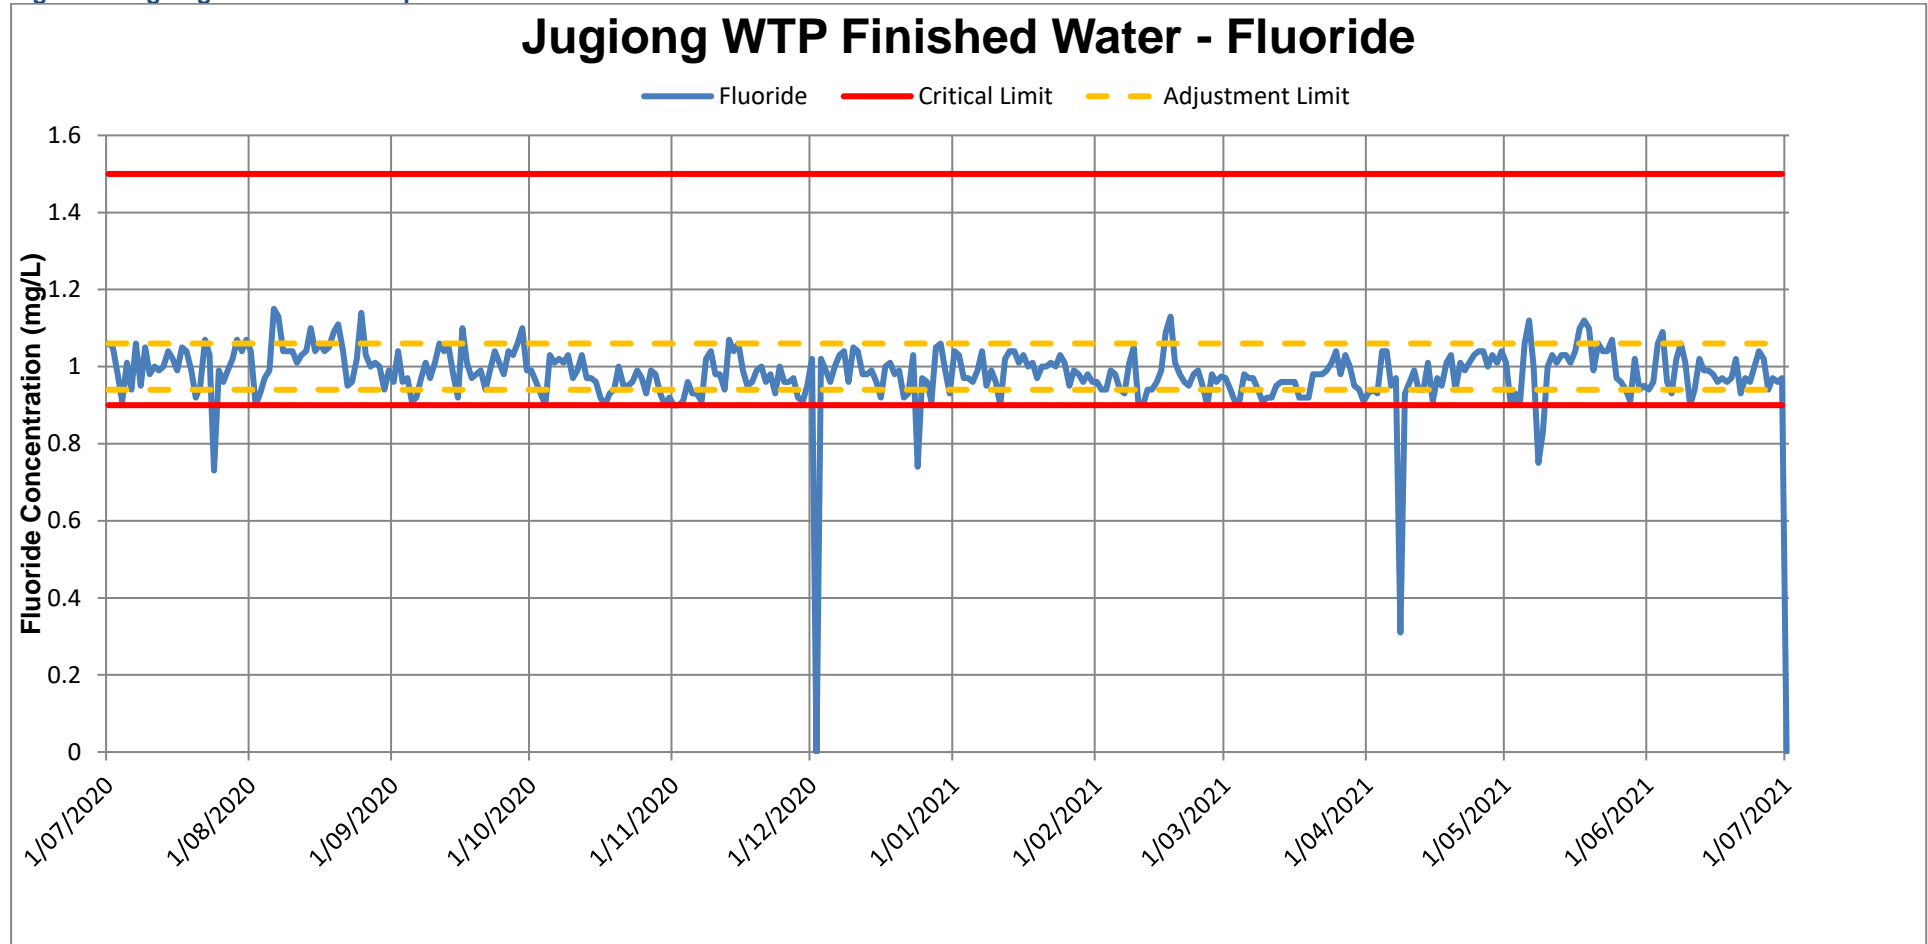
Figure 2. Jugiong water treatment plant - finished fluoride.

Figure 2 is a representation of the Finished Water Fluoride in the water leaving the Jugiong Water Treatment Plant. The red lines are our Critical Control Points (CCP) limits for the concentration of Fluoride in the water and the orange lines are our Operational control points. As is indicated above, GWCC is generally within the CCP throughout the year with the exception of 5 exceedances as indicated above. These exceedances are explained in Table 3 above, Critical Limit exceedances.

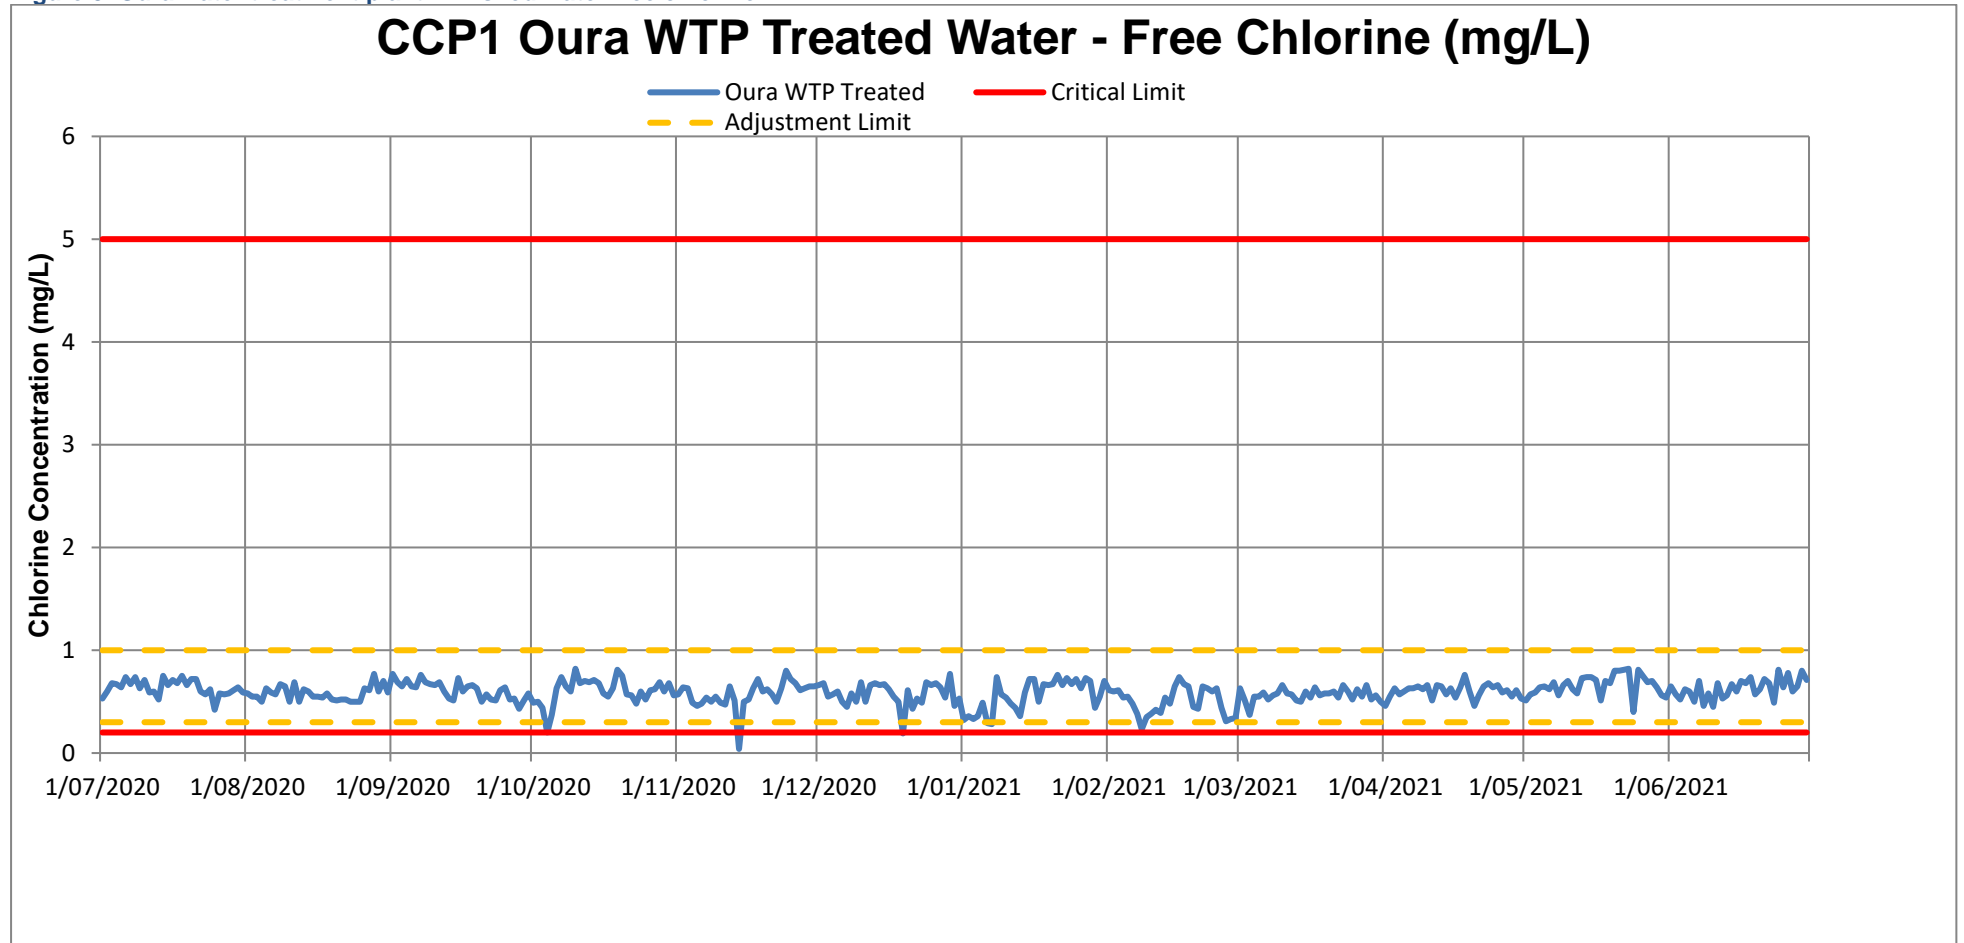
Figure 3. Oura water treatment plant - finished water free chlorine.

Figure 3 above is a representation of Free Chlorine in the water leaving the Oura Water Treatment Plant which employs a logarithmic scale on vertical axis. The red lines are our Critical Control Points (CCP) for the concentration of chlorine in the water and the orange lines are our Operational control points. As is indicated above, GWCC is consistently within the CCP throughout the year with only 1 exceedance and explained in Table 4 above.

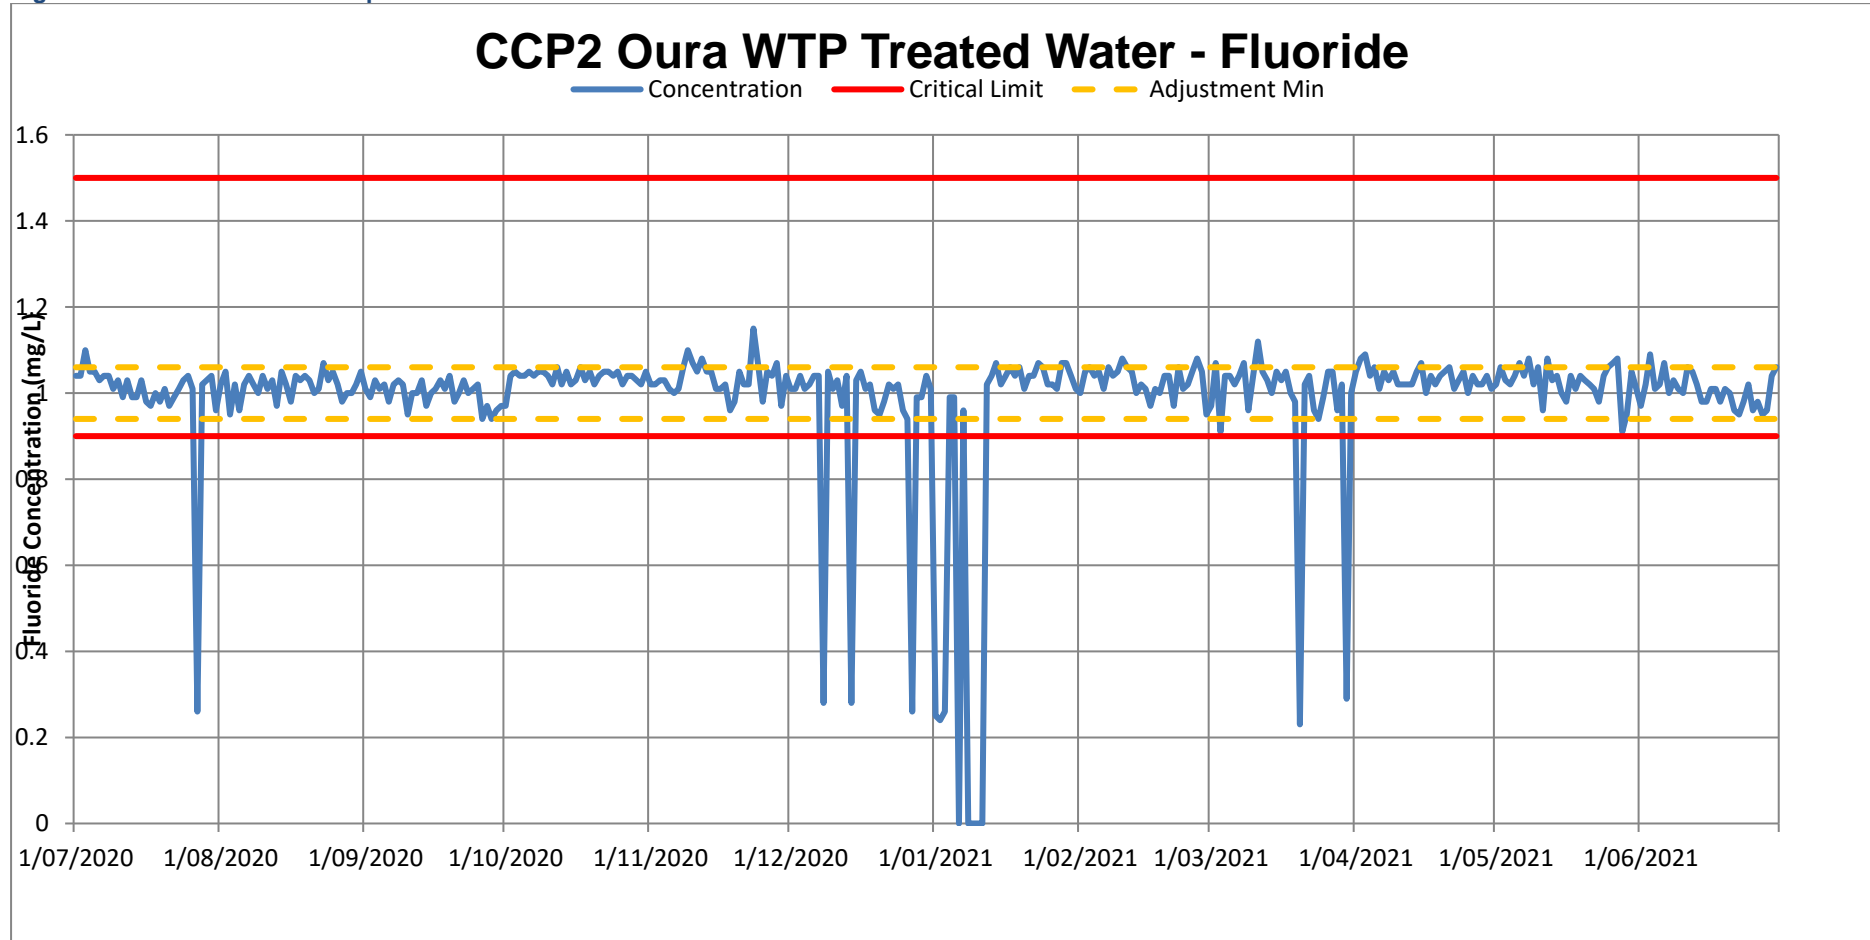
Figure 4. Oura water treatment plant - treated water fluoride.

Figure 4 above is a representation of the Finished Water Fluoride in the water leaving the Oura Water Treatment Plant. The red lines are our Critical Control Points (CCP) limits for the concentration of Fluoride in the water and the orange lines are our Operational control points. As is indicated above, there has been multiple exceedances throughout the reporting period, these exceedances have been explained in table 4 above.

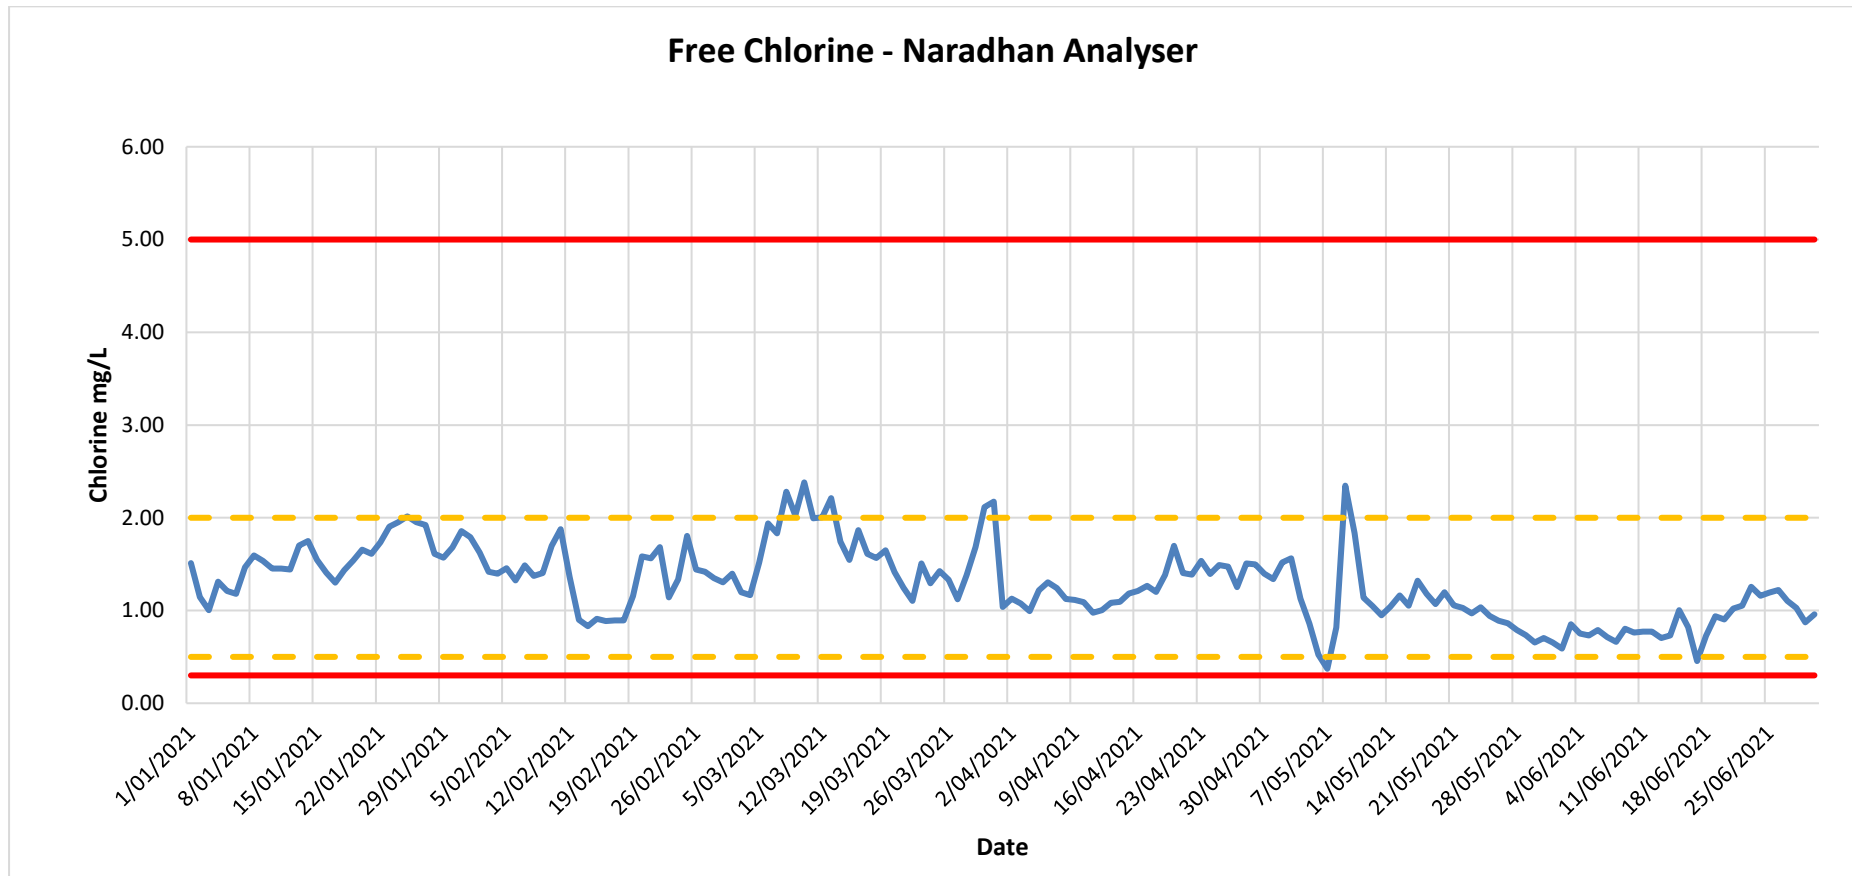
Figure 5: Mt Daylight finished water Free Chlorine

Figure 5 above is representative of the finished water Free Chlorine for the Mt Daylight system. As can be seen GWCC have only been receiving data from the new Clear SCADA since the 1<sup>st</sup> of January 2021. The red lines are our CCPs, and the orange lines are the operational limits. The readings are all within the critical limits.

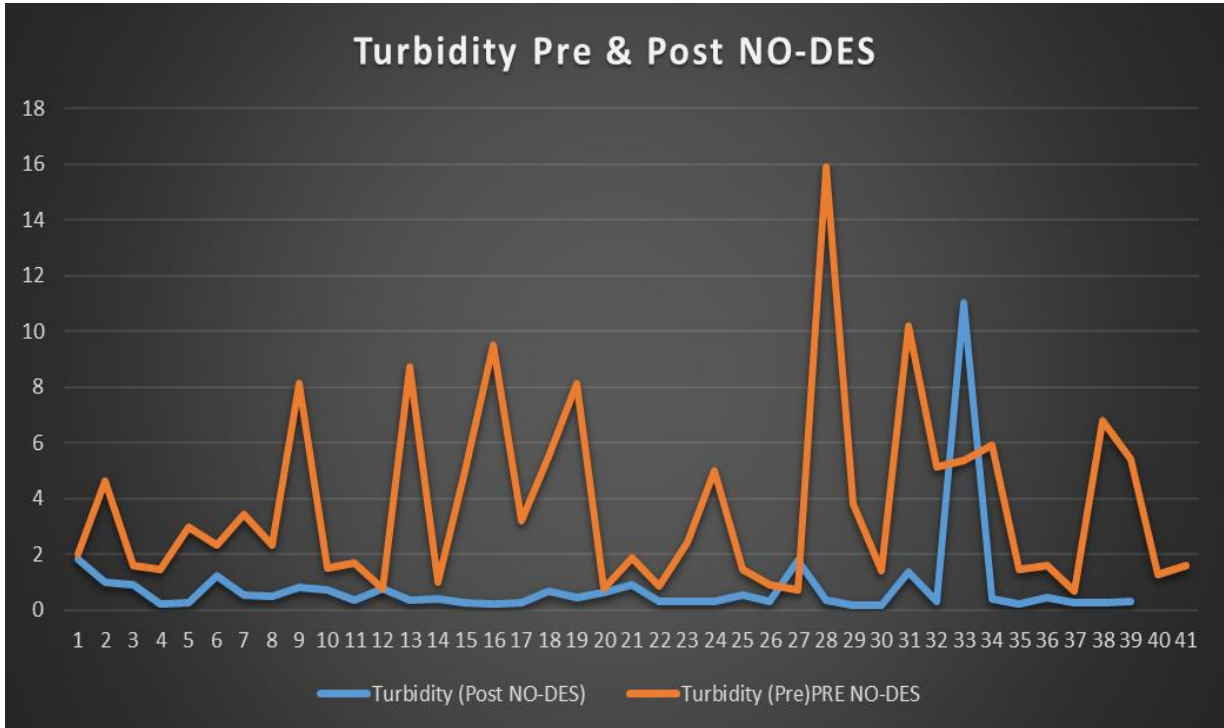
Figure 5: Turbidity Pre or Post No Des

The blue trend indicating a significant reduction in turbid water after the flushing program being completed. Spike shown was caused by Burst within the reticulation system.

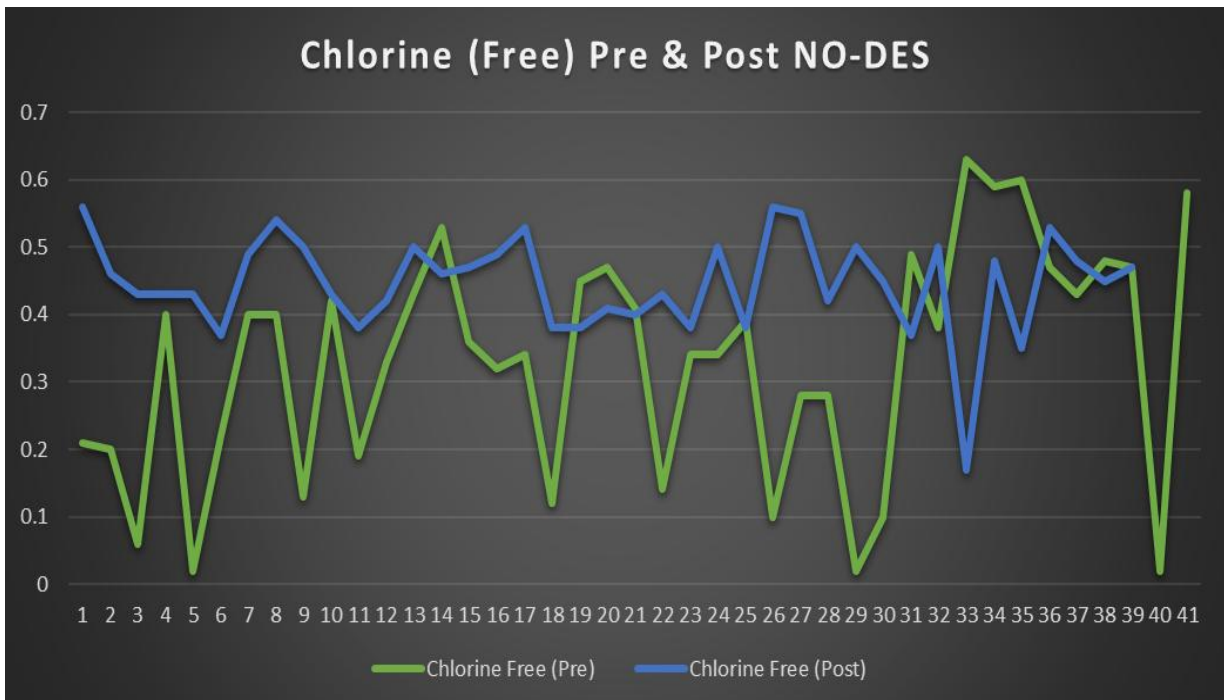
Figure 6: Free Chlorine Pre and Post No des

The below blue trend is indicating consistent levels of chlorine residual with improved water quality after NO-DES project. Dip correlates to the burst indicated within the above graph 2.

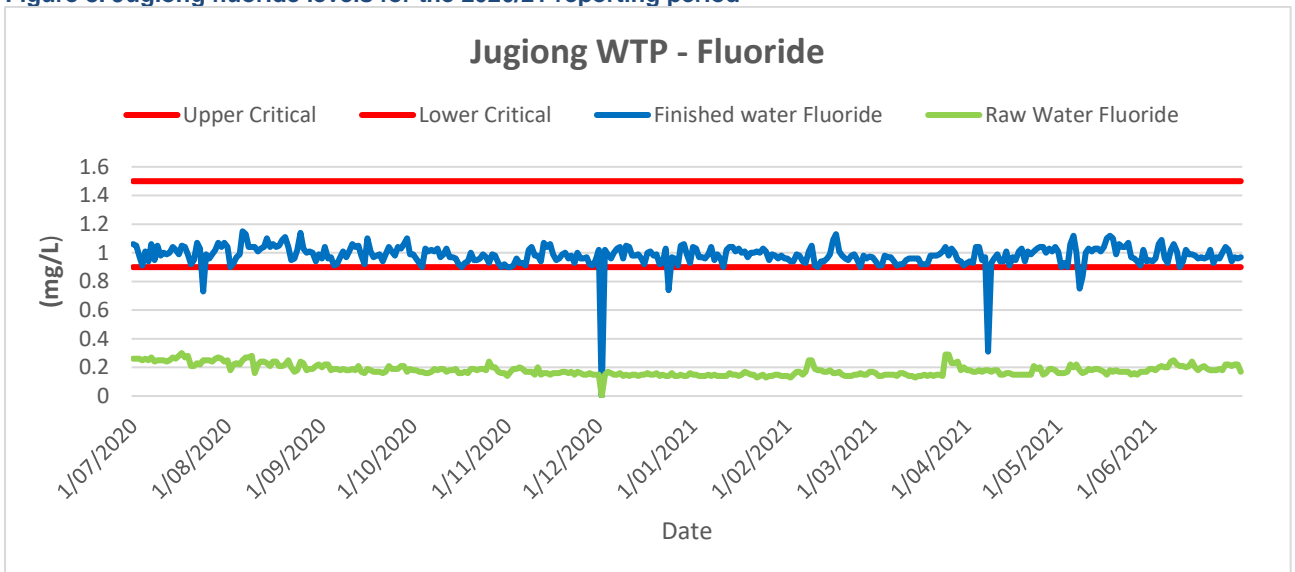
**Figure 8. Jugiong fluoride levels for the 2020/21 reporting period**

6 represents the finished water fluoride (Blue line) and Raw Water Fluoride (Green Line) for the Jugiong water treatment plant. Fluoride levels both Raw and Finished has remained consistent throughout the reporting period with a minimum value of 0.15 mg/L (Raw Water concentration) and a maximum value of 1.15 mg/L (Finished water Concentration). The Finished water Fluoride at the Jugiong Water Treatment Plant has failed to meet its minimum value of 0.95mg/L on only 5 occasions throughout the reporting period. These exceedances were due to equipment failure or breakdown.

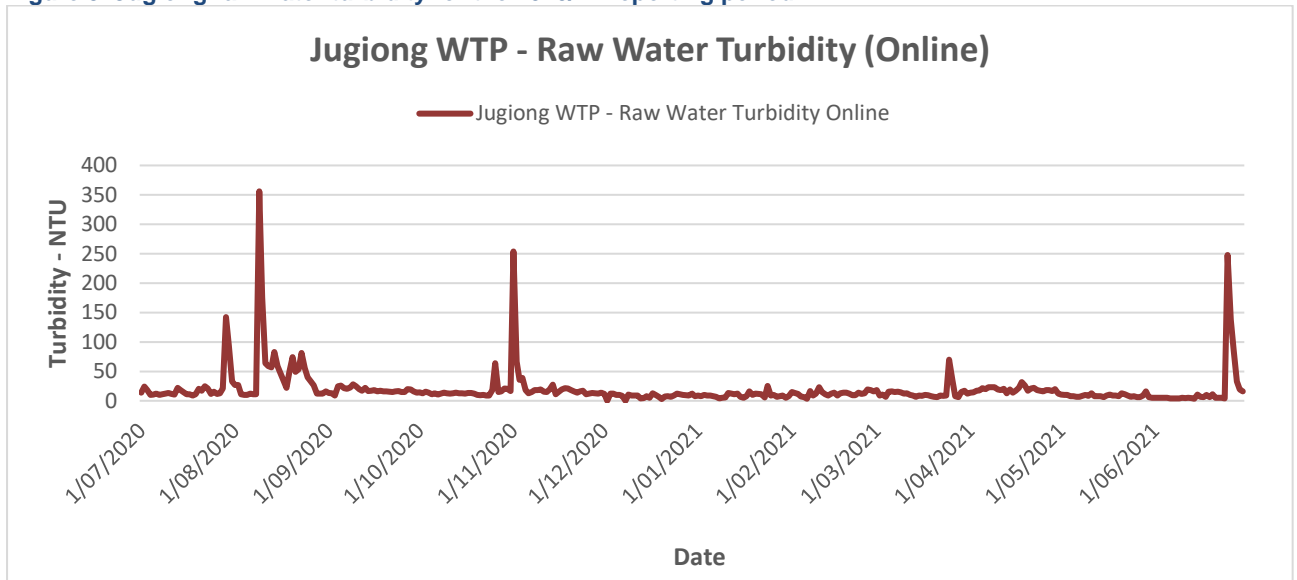
**Figure 9. Jugiong raw water turbidity for the 2020/21 reporting period**

BOM rainfall data indicates that the spikes in the Jugiong raw water can be attributed to heavy and /or sustained rain events that occurred upstream of the Water Treatment Plant.

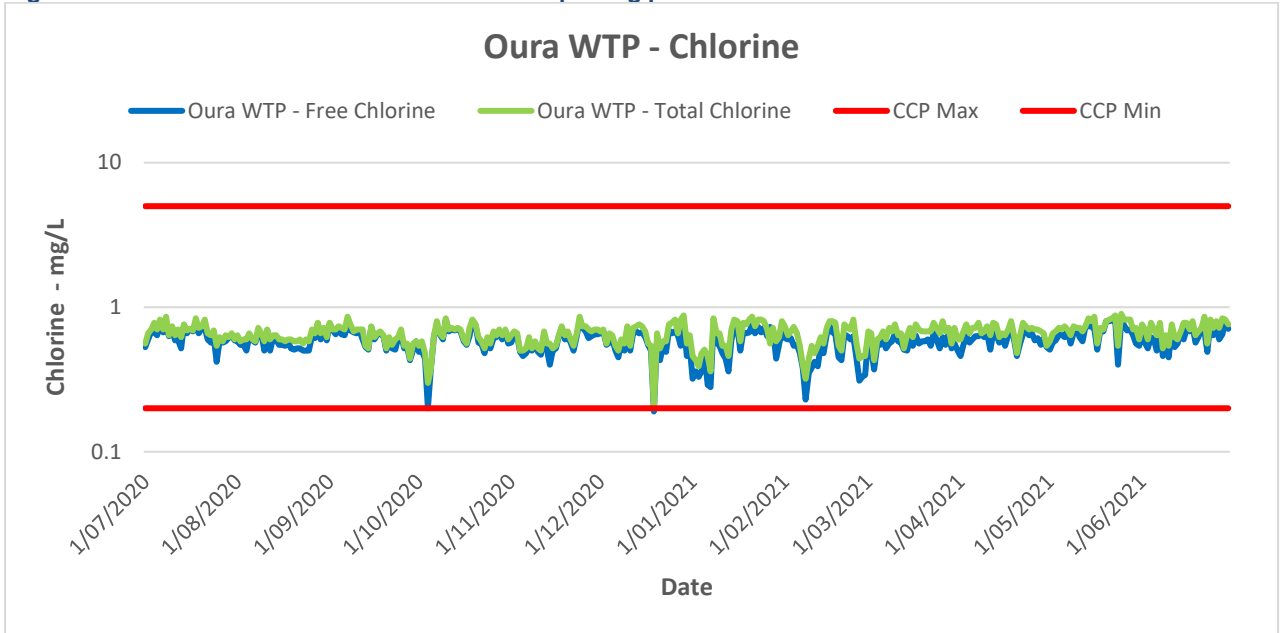
Figure 12. Oura chlorine levels for the 2020/21 reporting period

As can be seen in Figure 12, which uses a logarithmic scale on the vertical axis, the injection of chlorine into the Oura bore water has been extremely consistent throughout the reporting period. Averaging approx. 0.59mg/L (FCI) and 0.66mg/L (TCI) for the 12 months this is slightly higher than our target of 0.5mg/L but well within our CCP range of 0.2mg/L and 5mg/L. Overall a very good result for the Oura WTP operations.

There were no exceedances for chlorine dosing in the 2020/21 financial year.

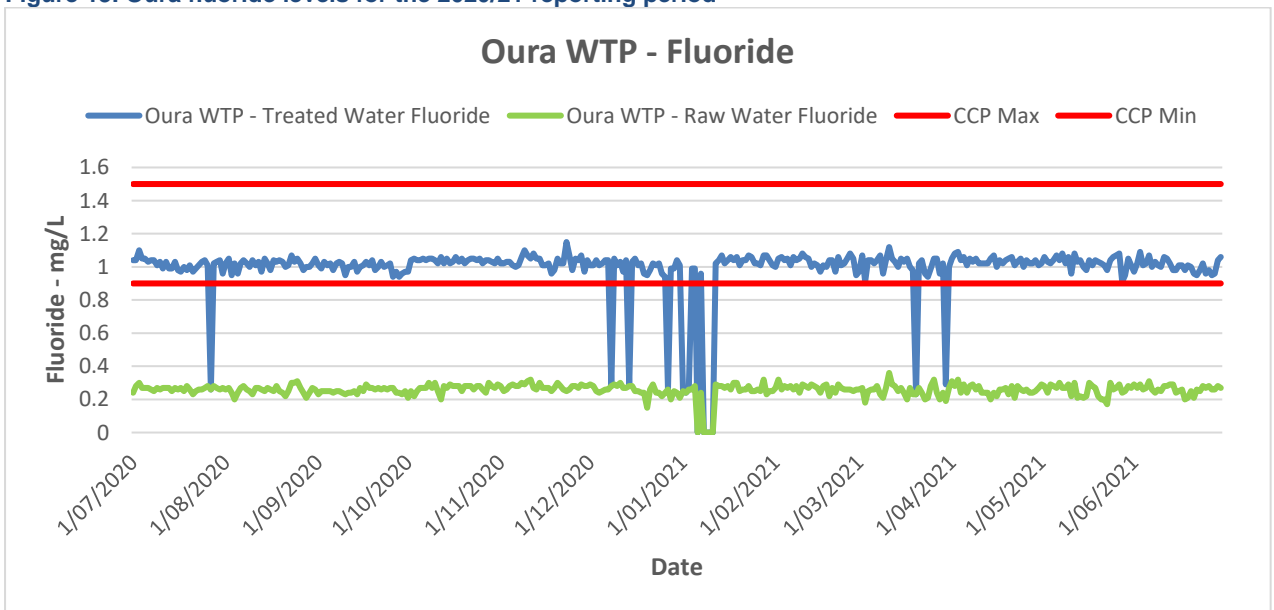
Figure 13. Oura fluoride levels for the 2020/21 reporting period

As can be seen in Figure 13, the raw fluoride content from the Oura Bores is very consistent remaining mostly between 0.2mg/L and 0.4mg/L for the reporting period 20/21. Raw water fluoride averaged 0.26mg/L for the 20/21 period.

The treated water fluoride was mostly consistent over the reporting period only recording 5 exceedances. **All exceedances were be attributed to equipment failure.**

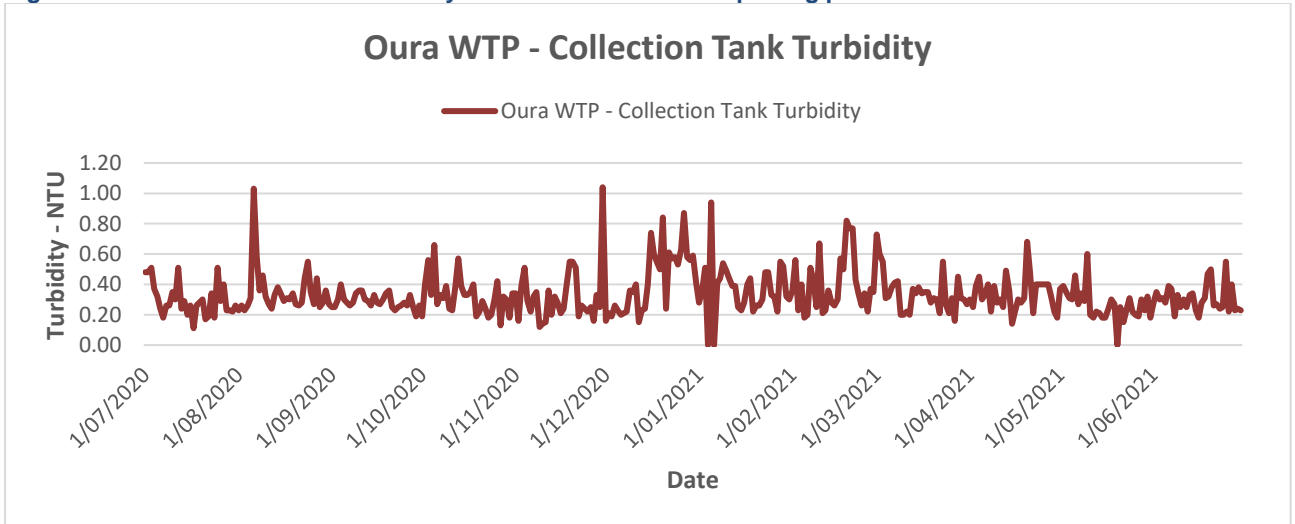
Figure 14. Oura collection tank turbidity levels for the 2020/21 reporting period

Figure 14 shows the turbidity at the Oura collection tank. Australian Drinking Water Guidelines (ADWG) indicates that turbidity should be <5 NTU (Nephelometric Turbidity Units). As can be seen, there have been no exceedances of this limit for the 2020/21 reporting period.

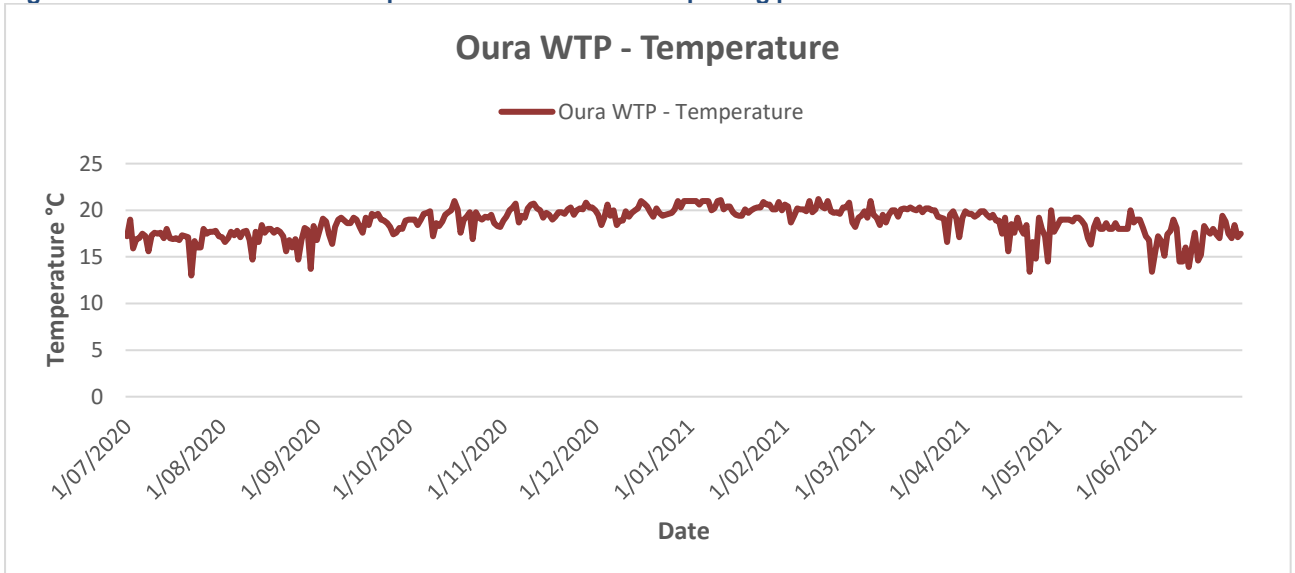
Figure 15. Oura treated water temperature for the 2020/21 reporting period

Figure 15 shows the relationship between the temperatures of the treated water with time over the reporting period. As you would surmise, it follows a seasonal trend in that the treated water is warmer in summer and colder in winter.
