Drinking Water Management System Annual Report 2023/24

Goldenfields Water County Council

Date: December 2024

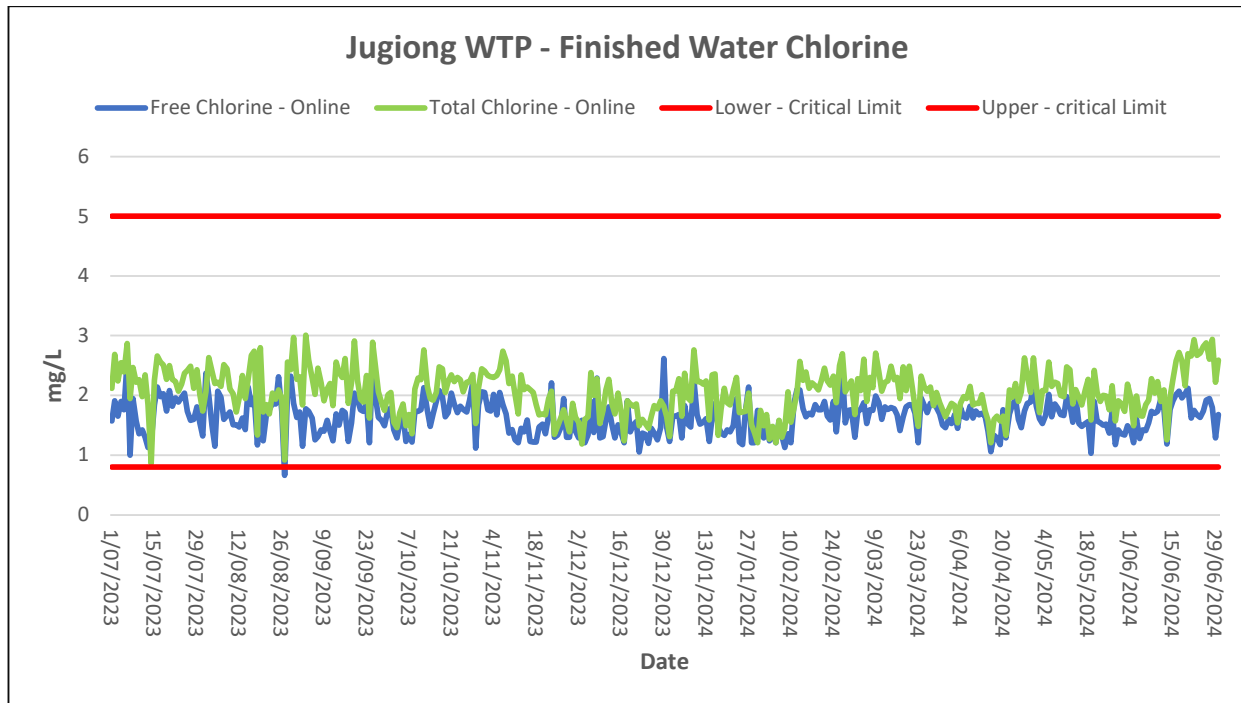
Figure 9 7. Jugiong chlorine levels for the 2023/24 reporting period

- The chlorine target leaving the WTP is 1.8mg/L with amber alerts sent if chlorine drops below 1.2mg/L or goes over 2mg/L.
- The alert becomes critical with DWMS protocols implemented when chlorine levels drop below 0.8mg/L in summer and 0.5mg/L in winter. Figure 9 7 below represents the finished water chlorine at the Jugiong WTP, both Free and Total. As can be seen, GWCC has only exceeded its lower critical limit (<0.5mg/L, winter, <0.8mg/L summer) or its upper critical limit (>5.0mg/L) for Free Chlorine 1 time throughout the reporting period.
- A free/residual chlorine of 0.66mg/L was the lowest recorded result on the 26/08/2023. The highest total chlorine recorded was on the 3/9/2023 with a value of 3.01mg/L.
- The average Free Chlorine for the reporting year was 1.64mg/L and average Total chlorine reading was 2.06mg/L.

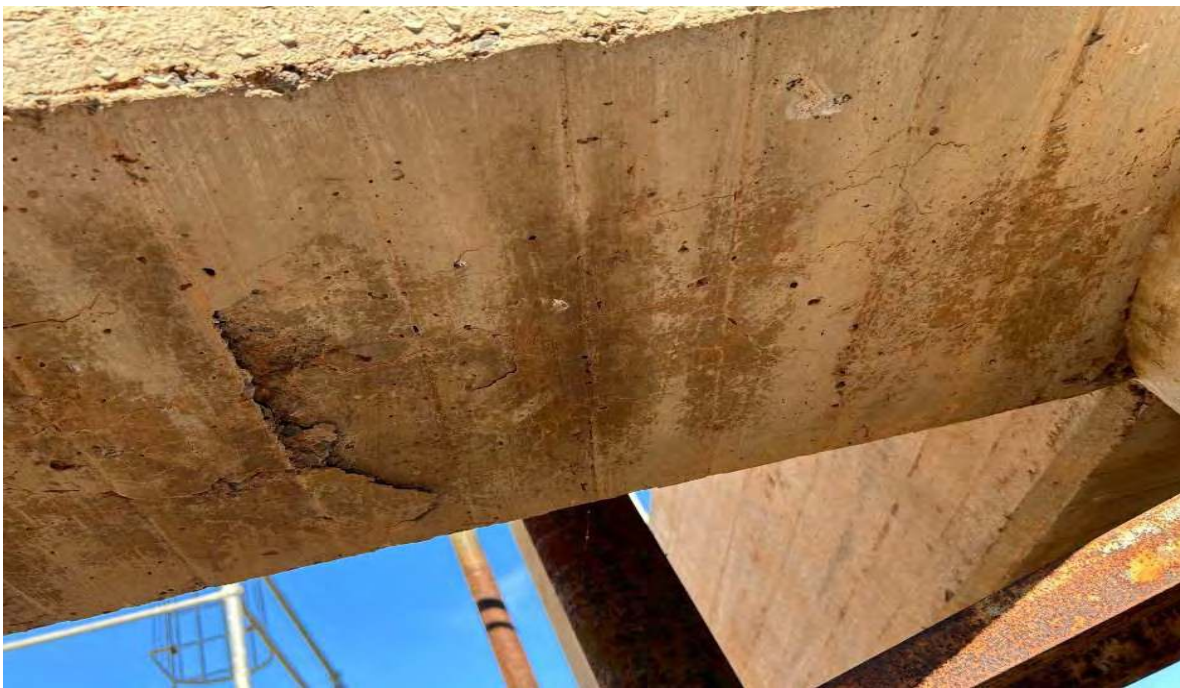
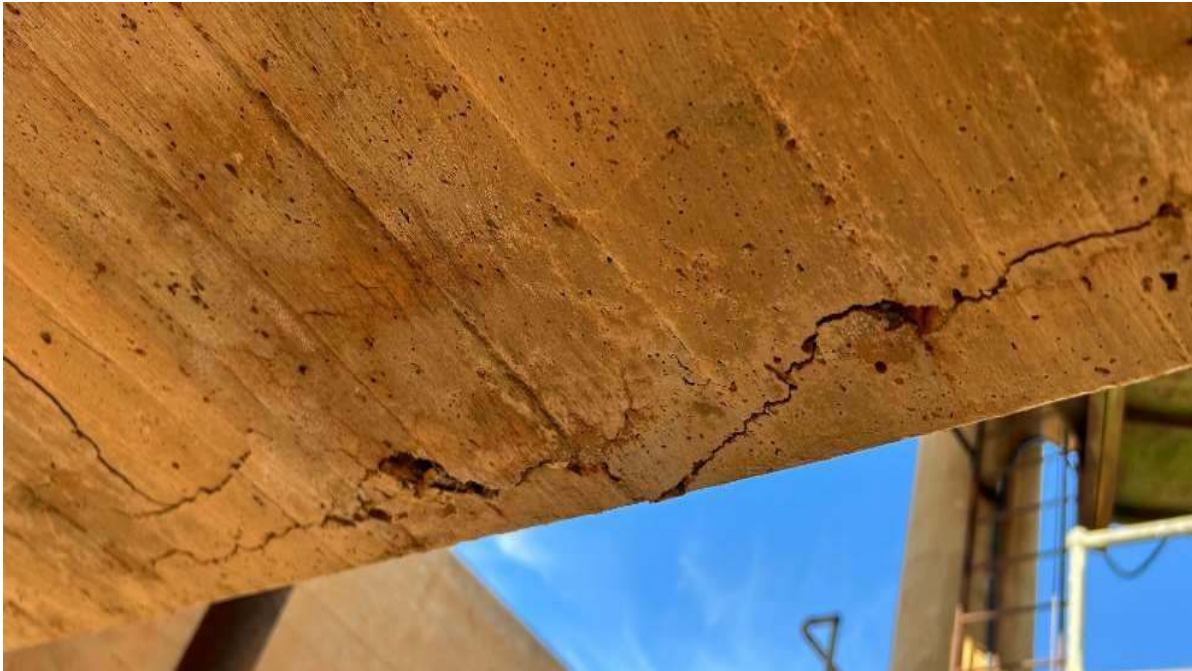
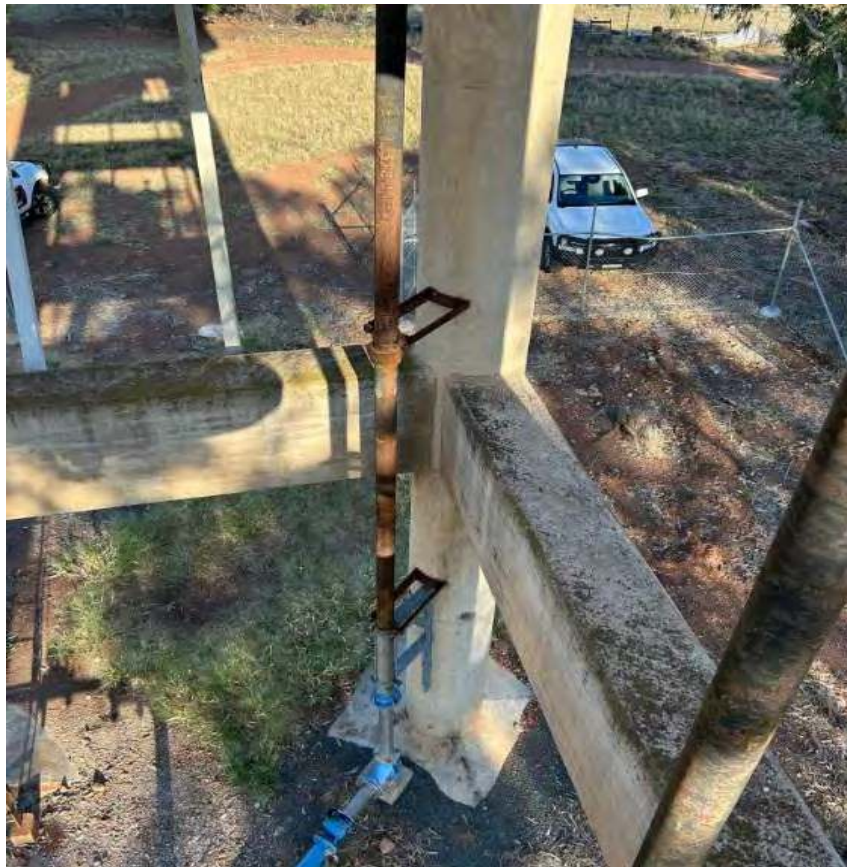
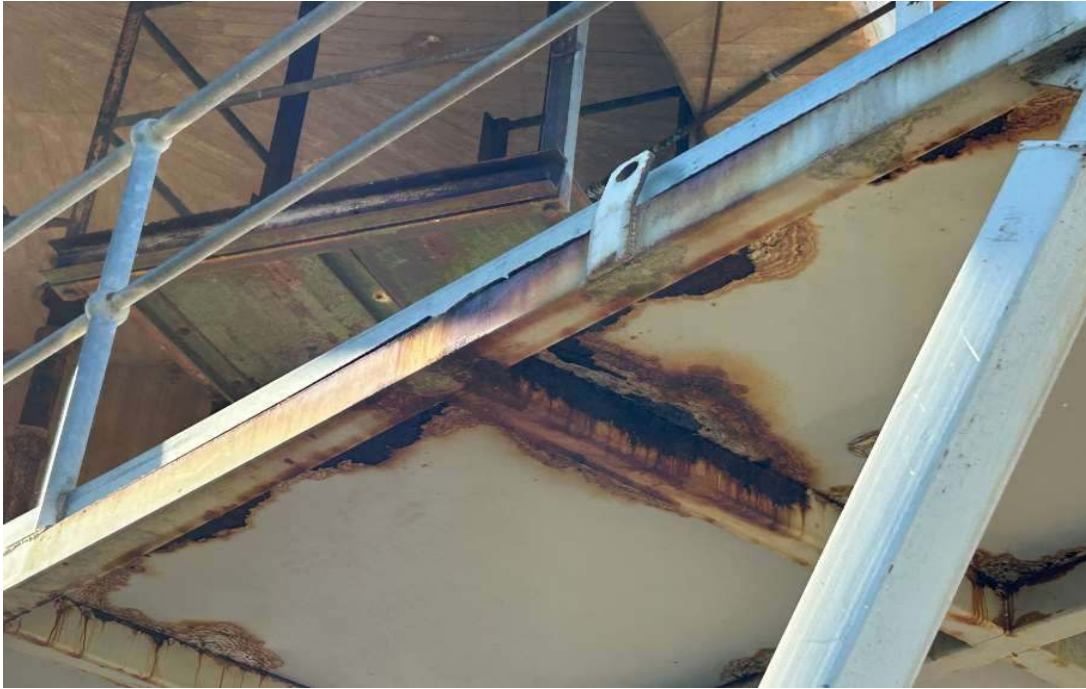
- External cross beam is severely damaged and requires repairs
- Injection to stop any water leaks
- External Pipework has dropped slight but no action is required – Council should Reinspect in a year
- Rust Repairs to access platform

Top beam spalling Concrete repairs

Rust Repairs to Platform

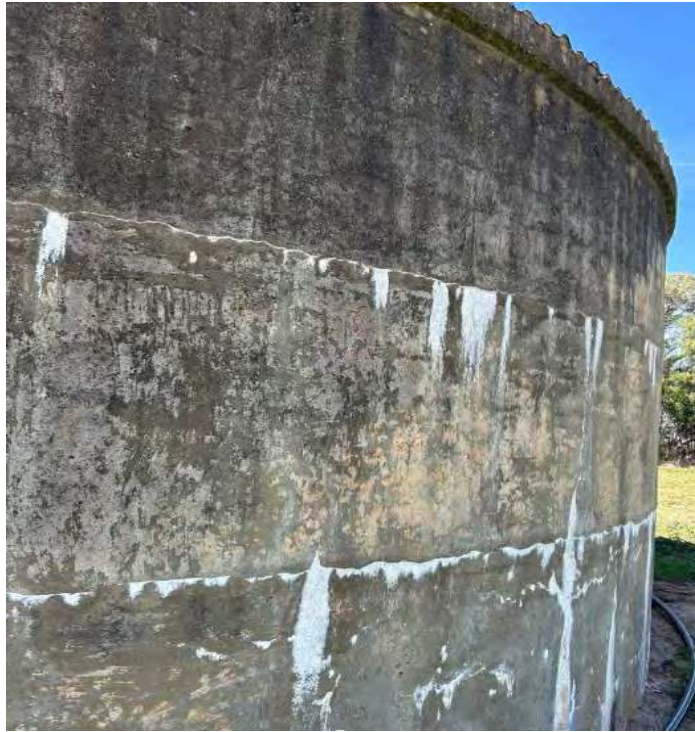
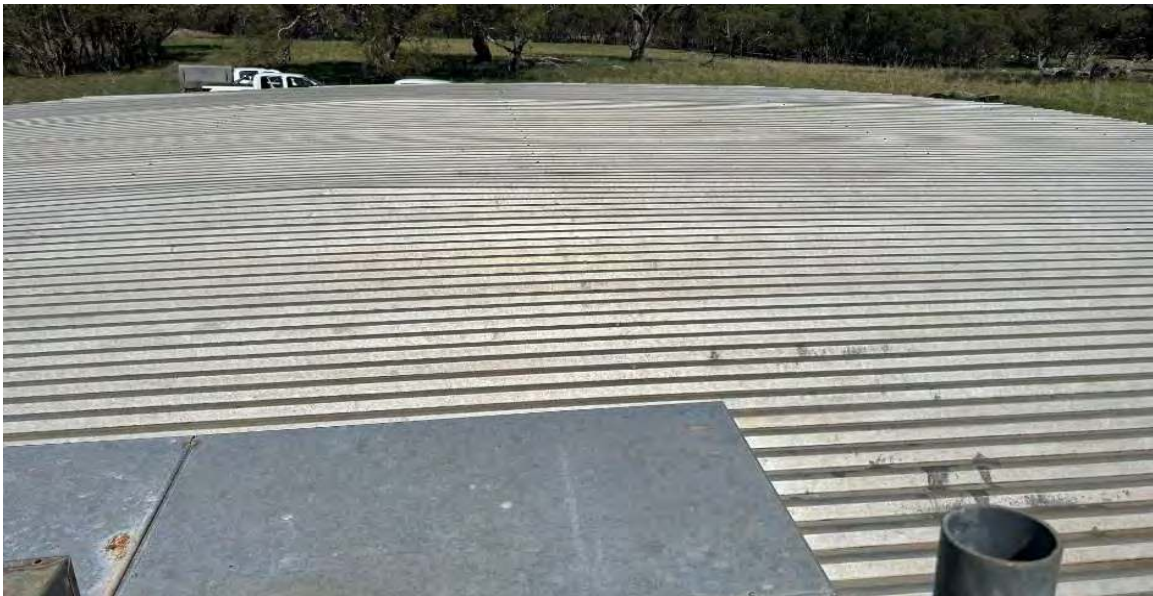
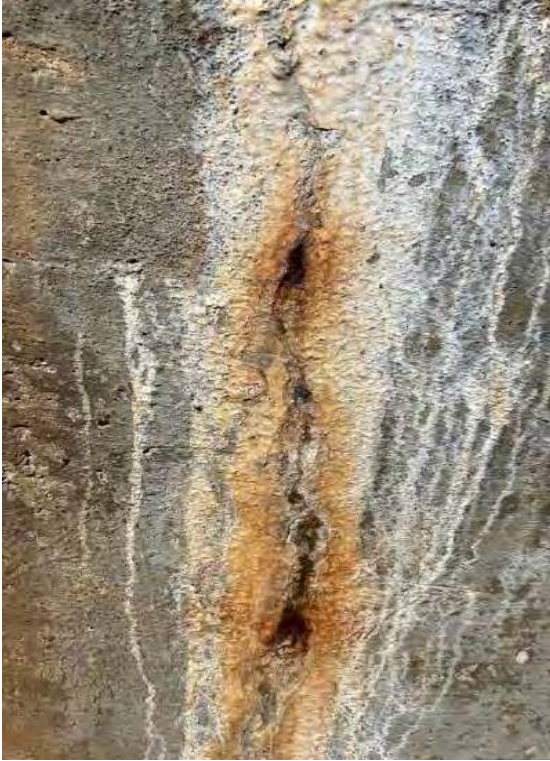
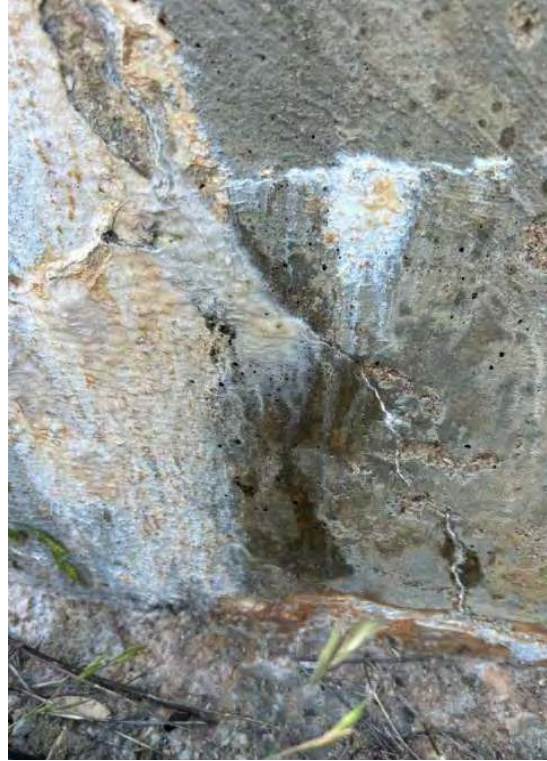
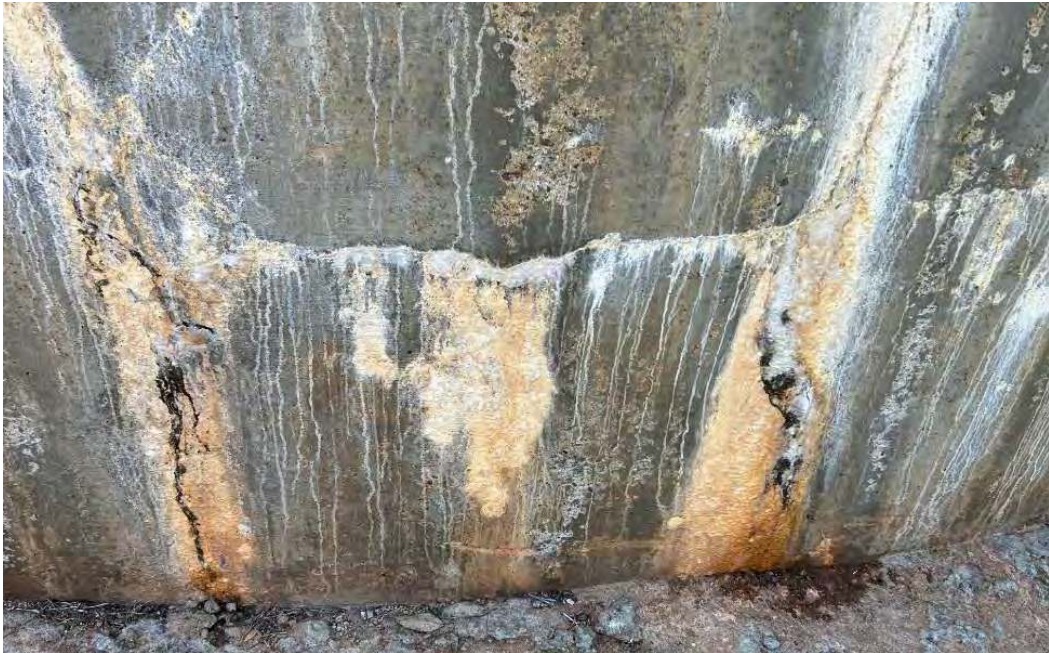
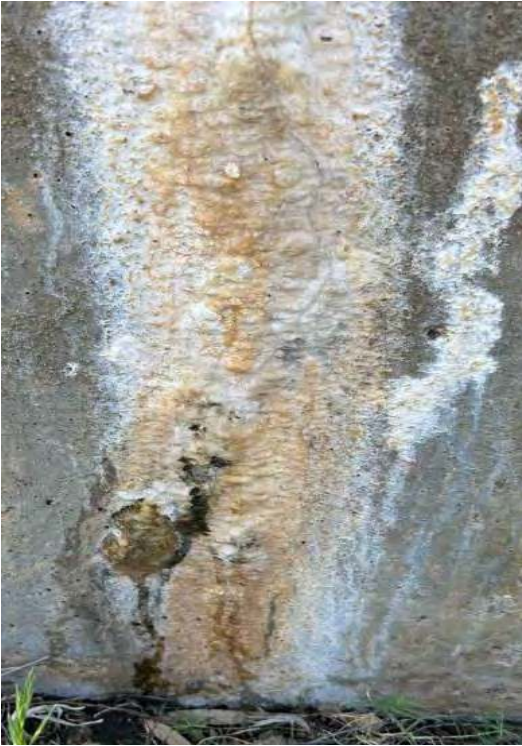
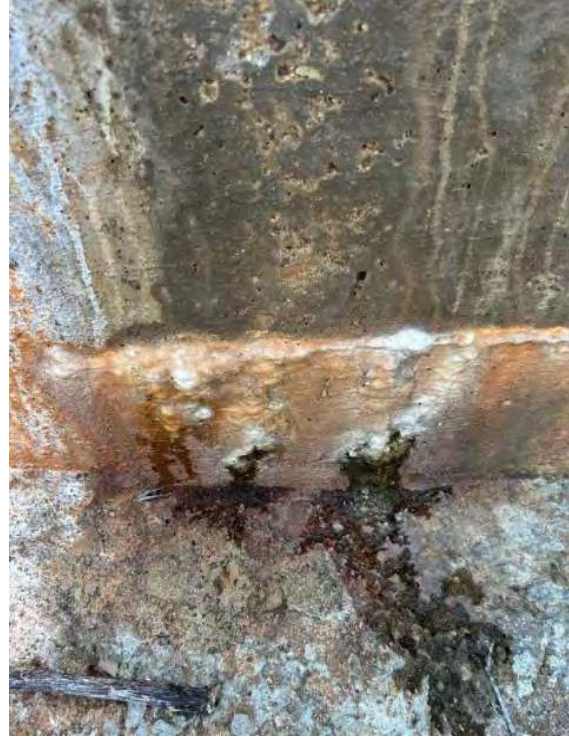
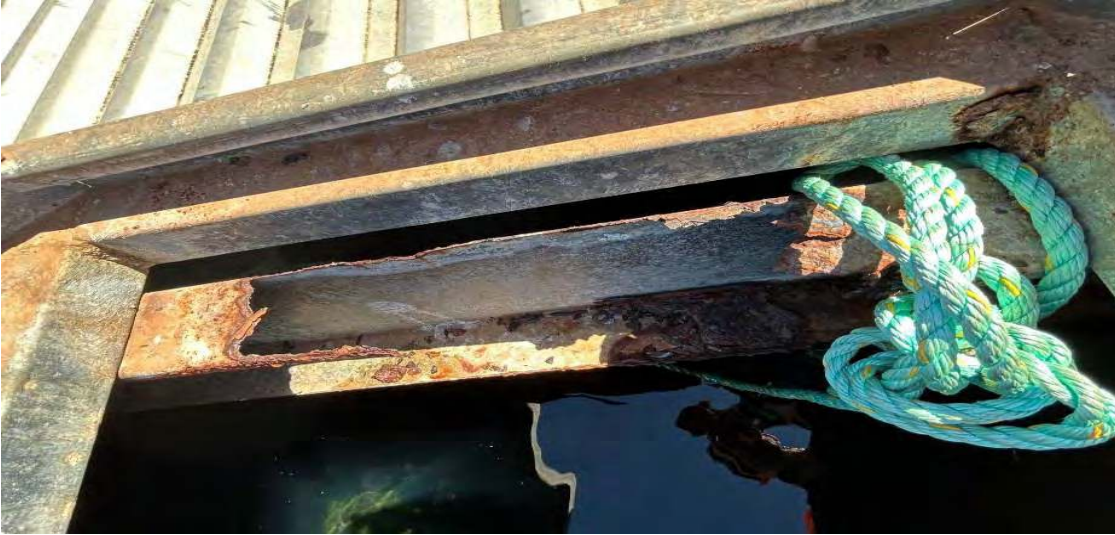
- External Wall has various cracks and Leaks that require repairs
- External Access Ladder is rusted and requires rust to be treated
- 4 x Internal roof Beams are very rusted and require repairs
- Internal pipework hooks are rusted and council should replace them soon

- **Roof beam Repairs for Rust Damage** - Abrasive Grit Blast and Coat with Anti corrosive coating
- **Crack Injection For Water Leaks** - Carry out Leak Sealing as required using Polyurethane injection

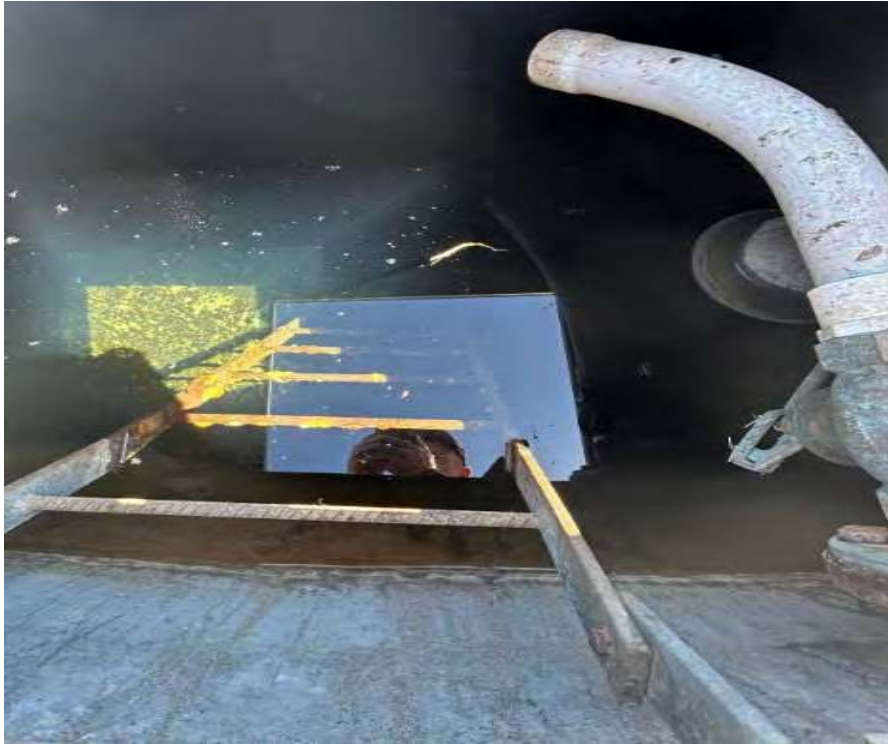
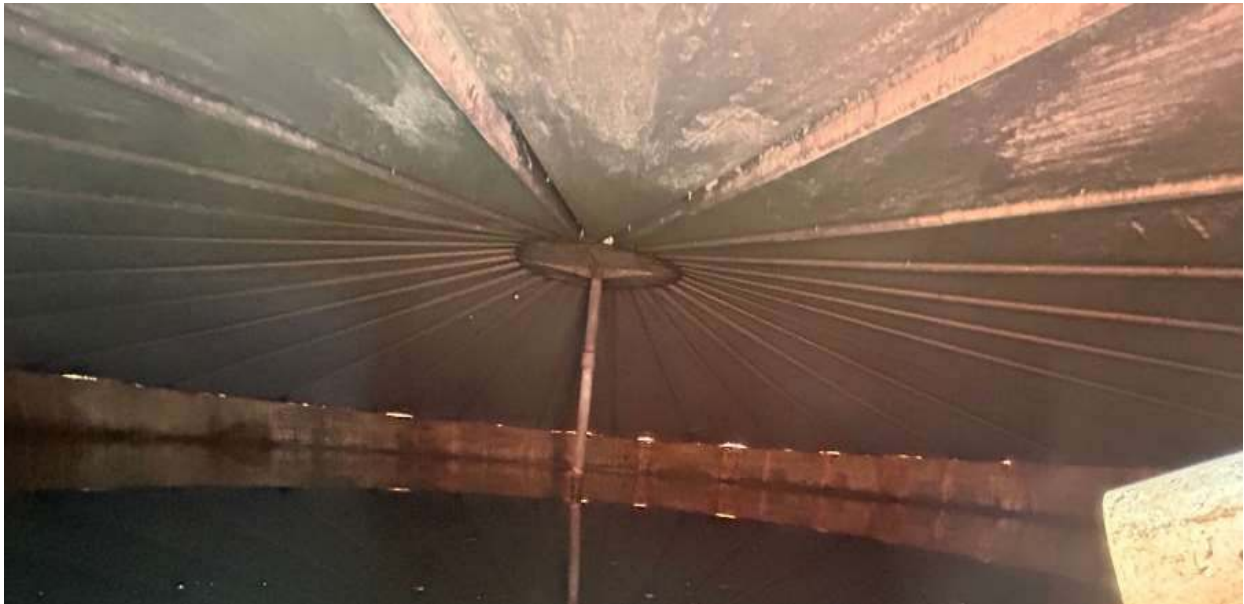
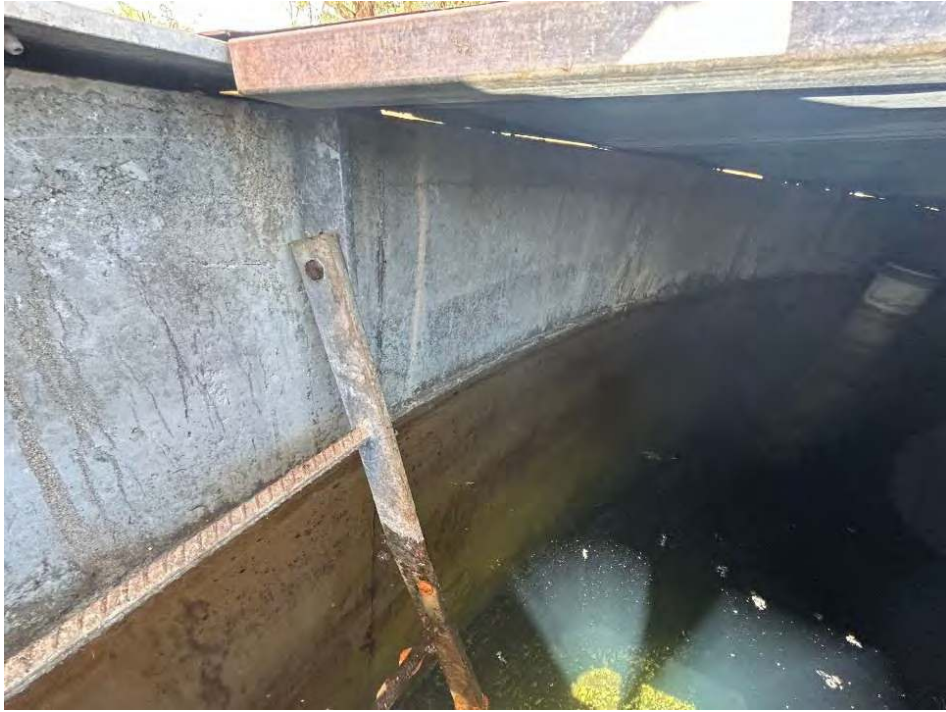
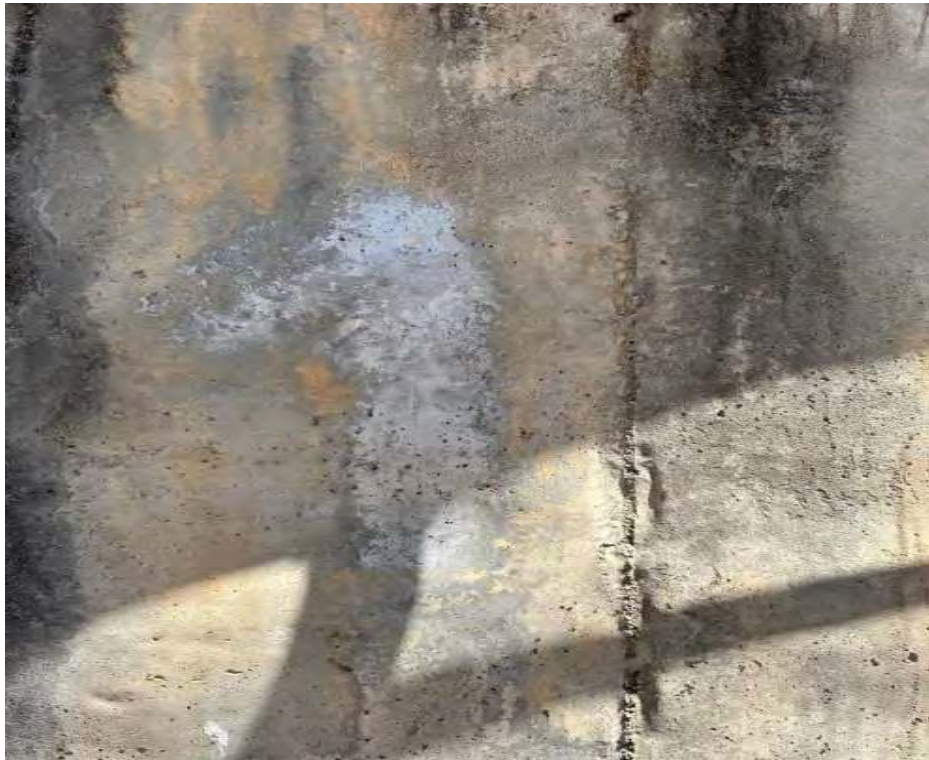
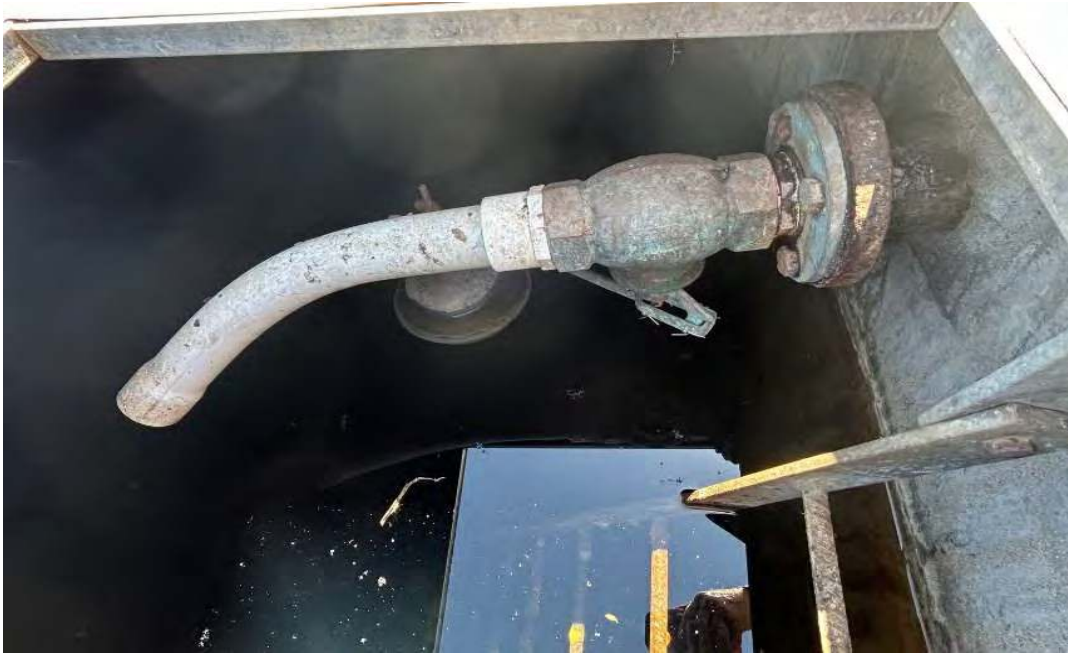
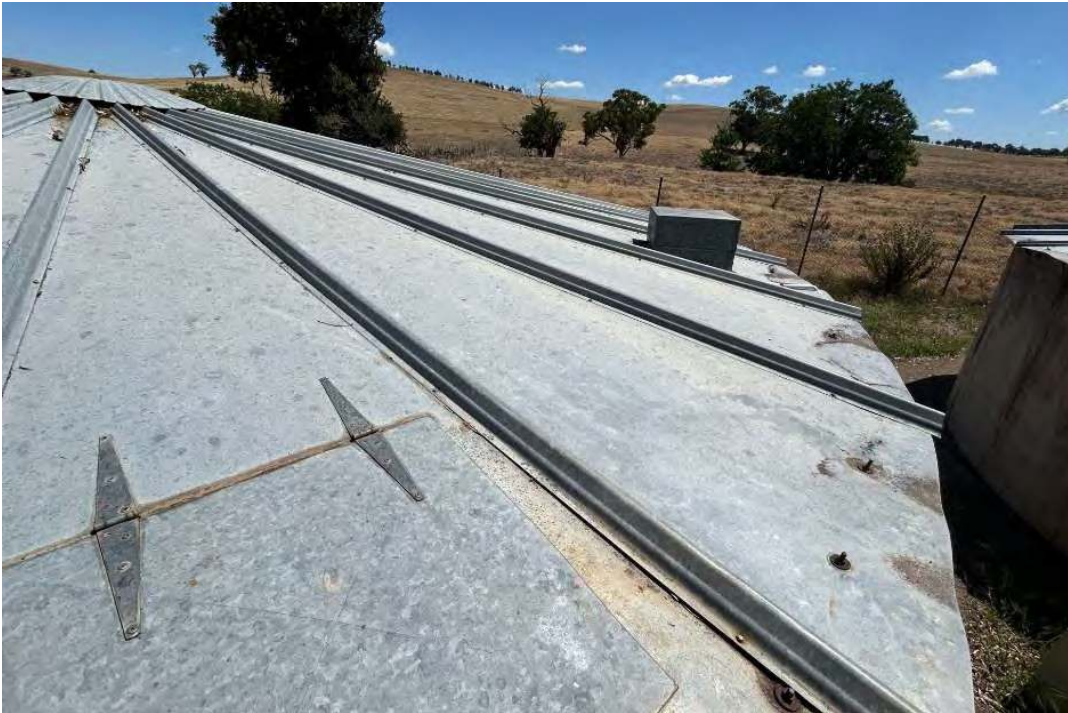
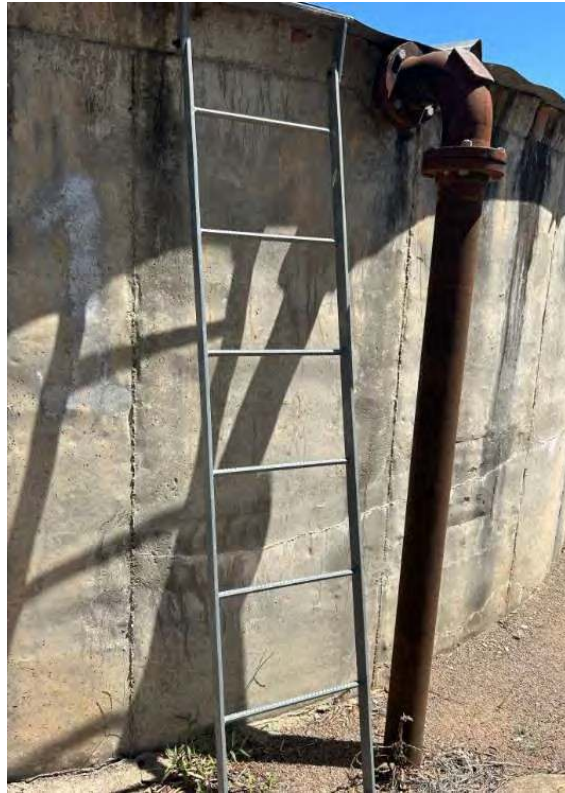
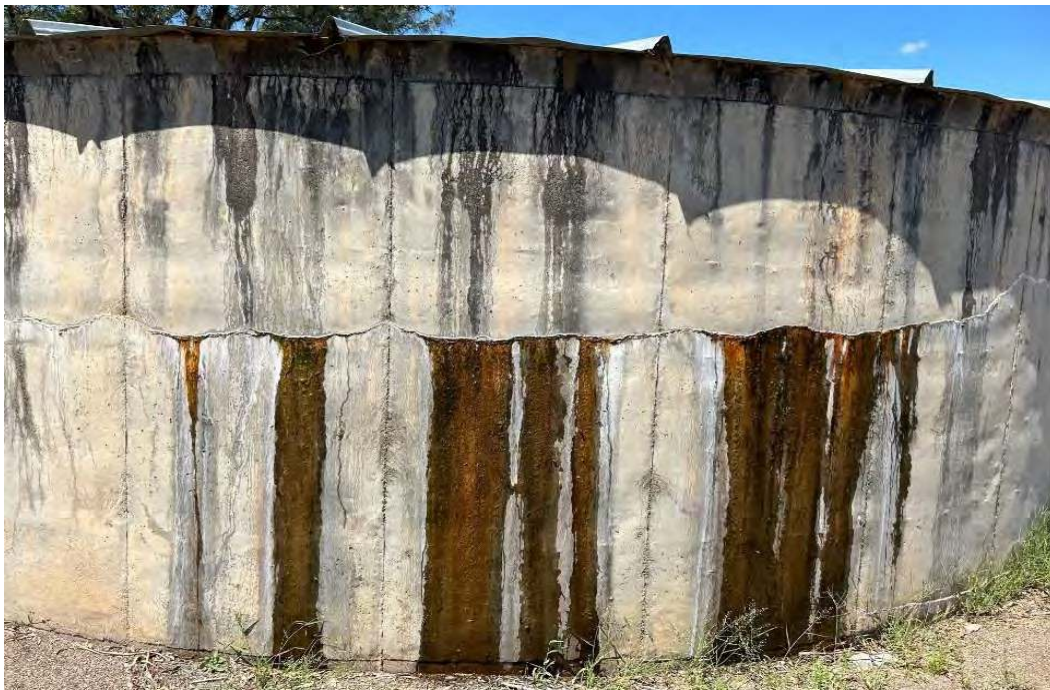
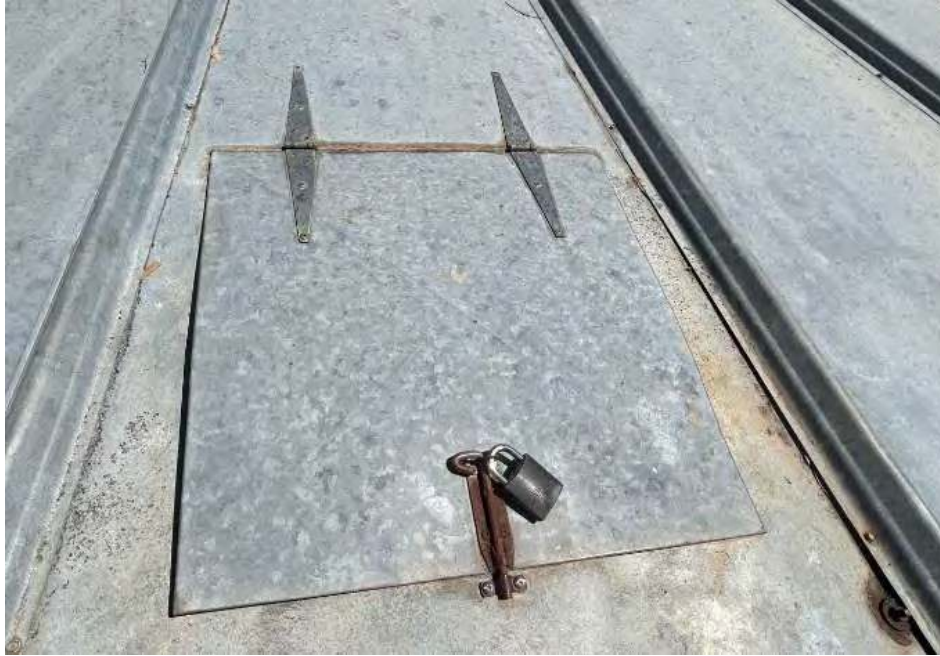
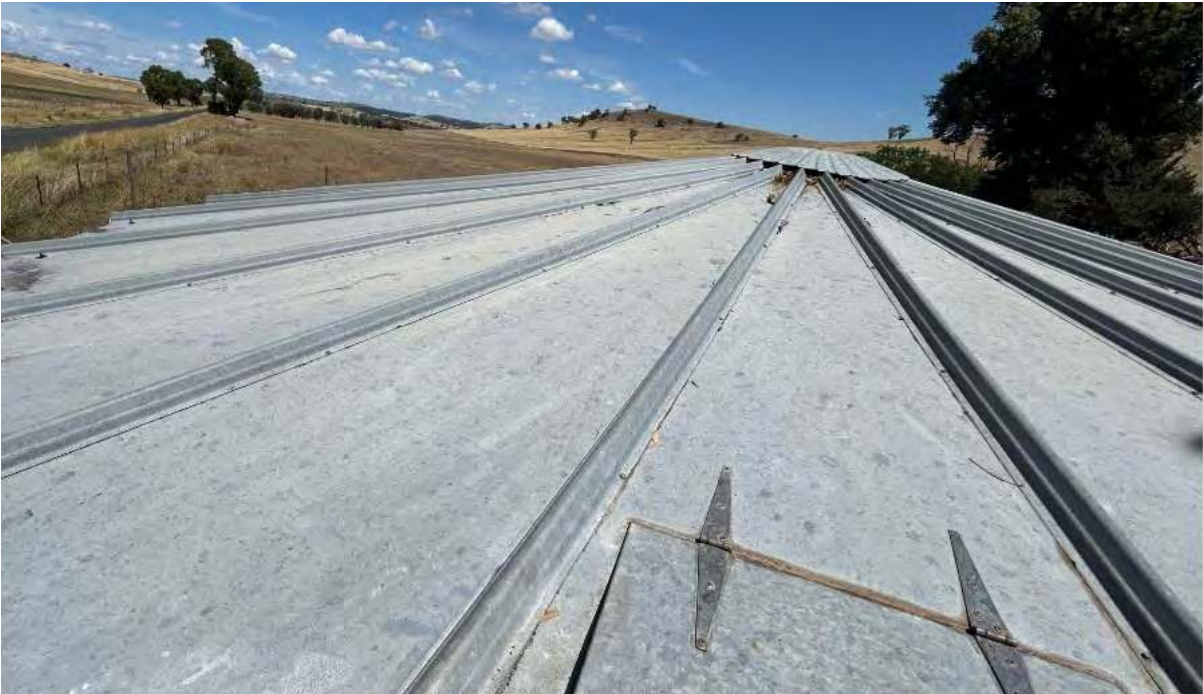
SITE PHOTOS

- External Wall has visible cracks that is 4 meters long that need to be repaired
- External Valves & Pipework is slightly rusted

SL NO	ITEM DESCRIPTION	DEFECTS	GRADING KEY	REMARKS
1	External Wall - General	1 large crack is visible	3 - Fair	
2	External Wall - Concrete/Reo		2 - Good	
3	External Access Ladder		2 - Good	
4	Metal Roof		2 - Good	
5	Roof Access Hatch		2 - Good	
6	External Valves & Pipework	Slight rust present	3 - Fair	
7	Internal Wall - General		2 - Good	
8	Internal Wall - Concrete/Reo		6 - N/A	Unable To See reservoir is full of water
9	Internal Wall & Floor Joints		6 - N/A	Unable To See reservoir is full of water
10	Internal Access Ladder		2 - Good	
11	Internal Pipework		6 - N/A	Unable To See reservoir is full of water
12	Floor Inlet & Scour point		6 - N/A	Unable To See reservoir is full of water

- **Crack Injection Repairs on External wall** - Carry out Leak Sealing as required using Polyurethane injection
- **Rust Repairs on External Valves & Pipework** - Abrasive Grit Blast and Coat with Anti corrosive coating
