Drinking Water Management System Annual Report 2023/24

Goldenfields Water County Council

Date: December 2024

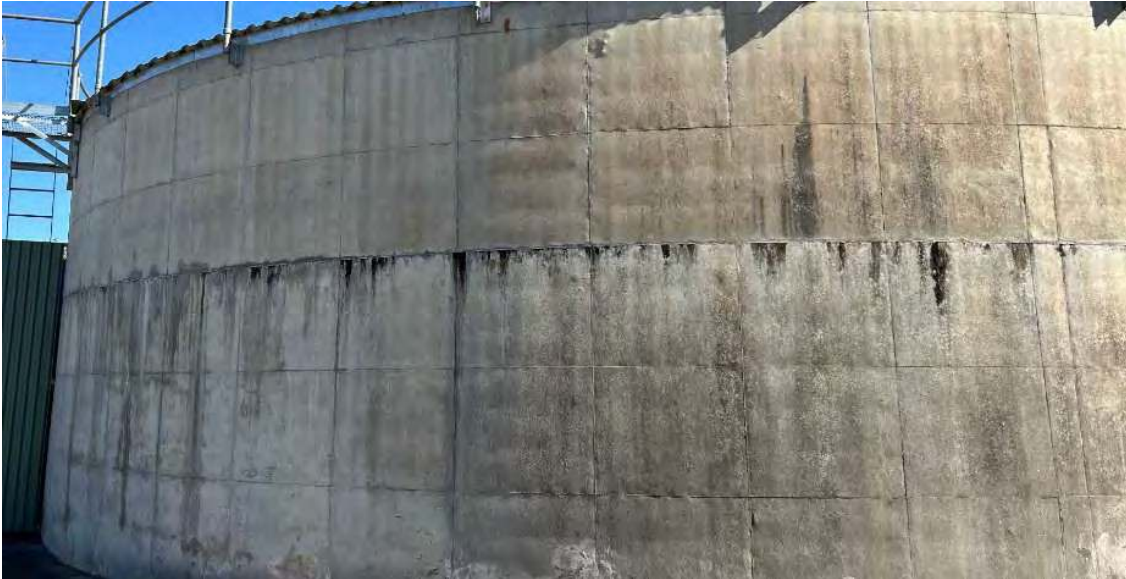
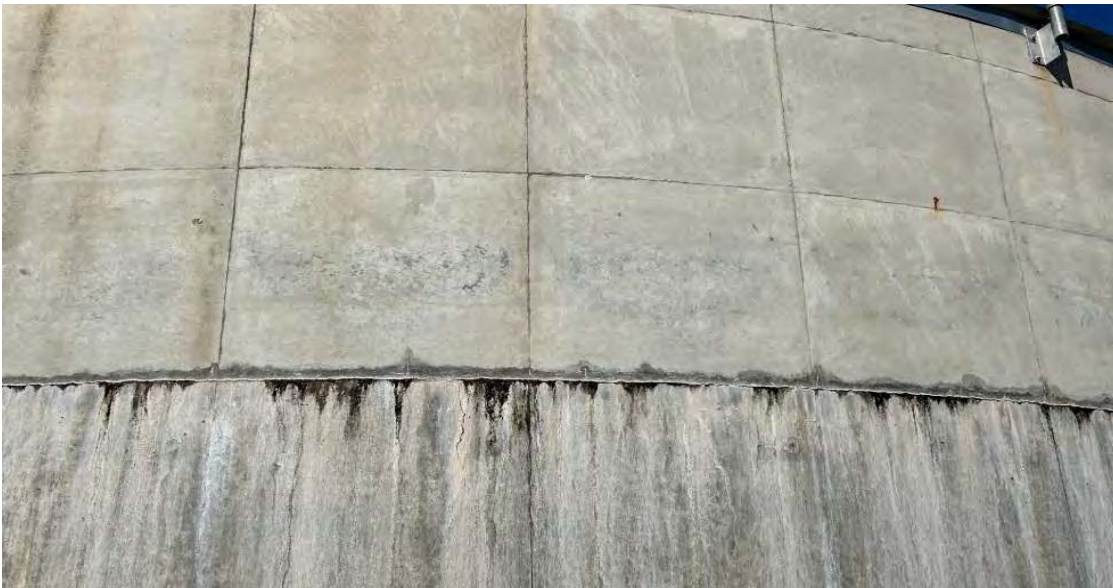
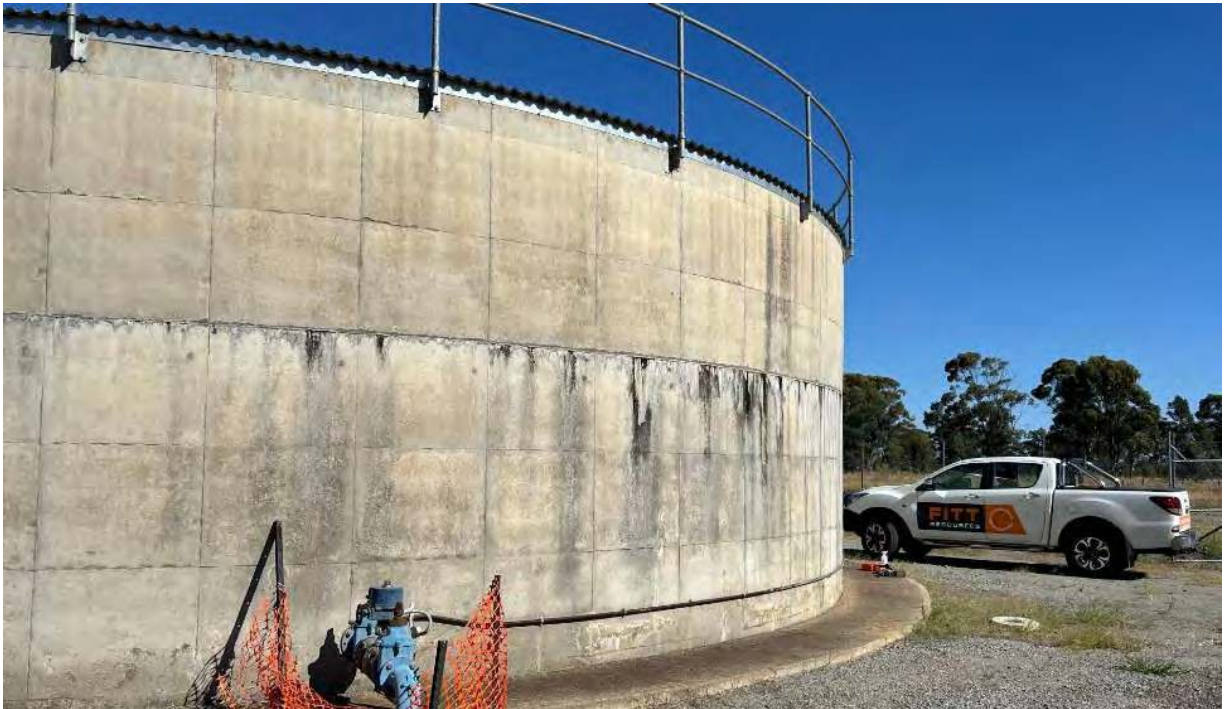
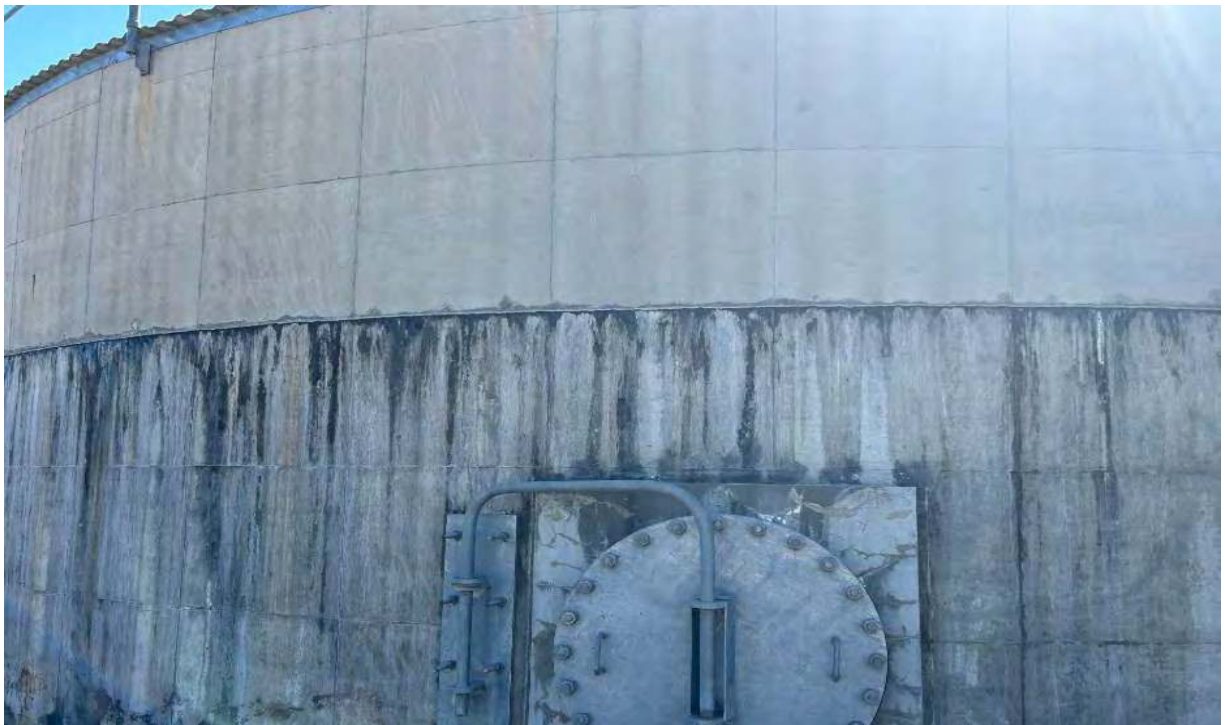
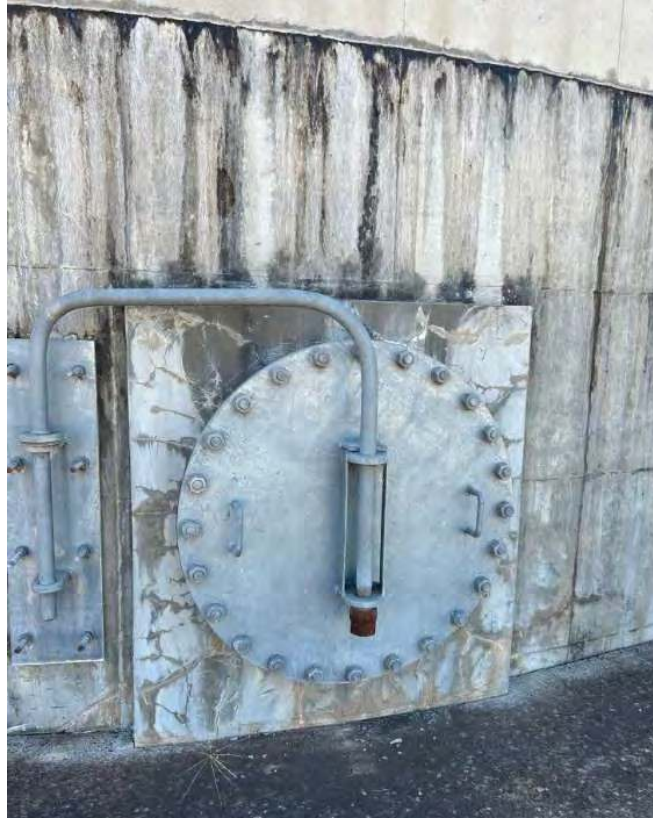
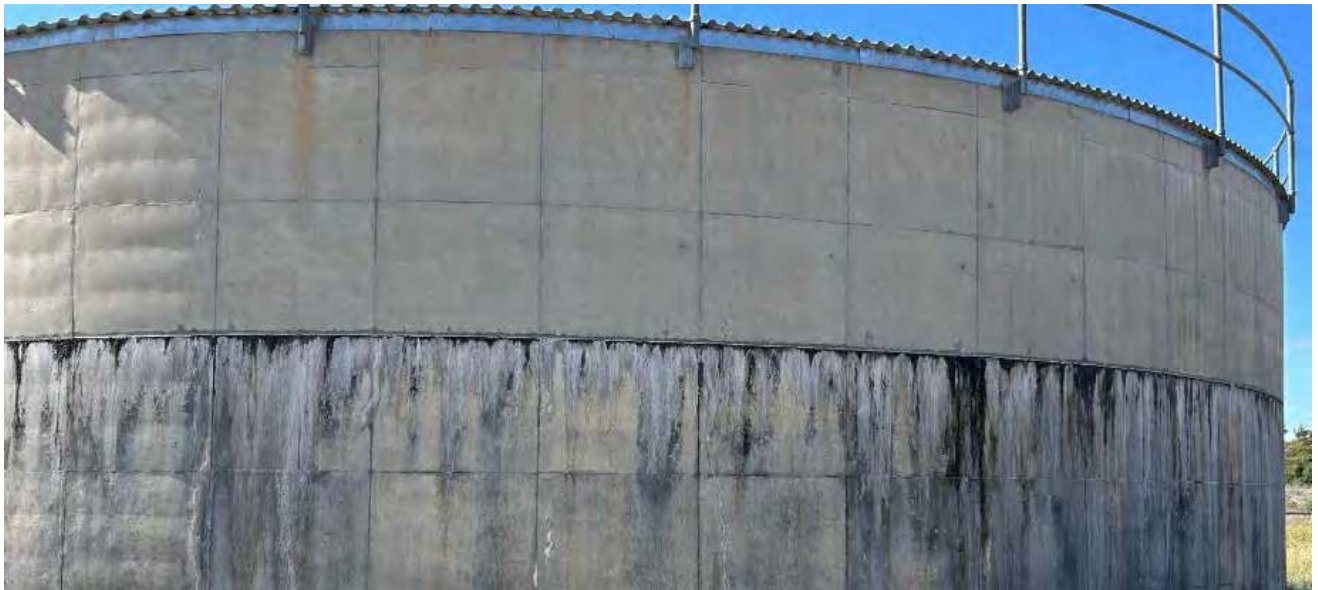
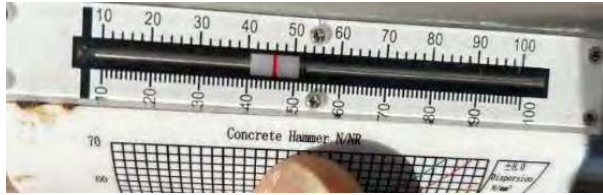
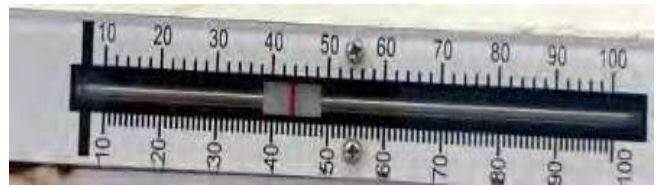
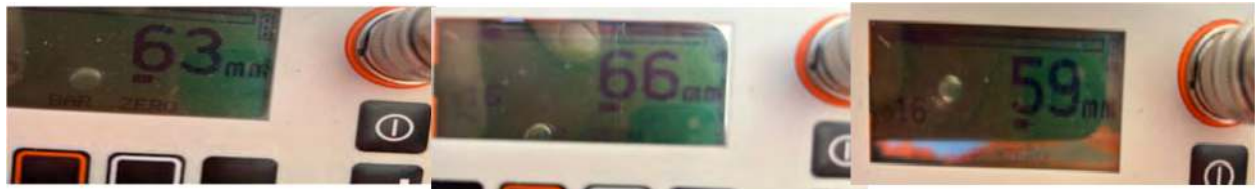
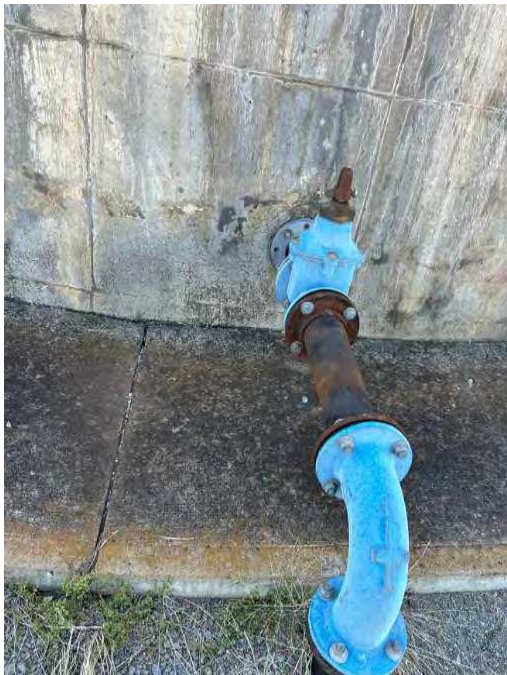
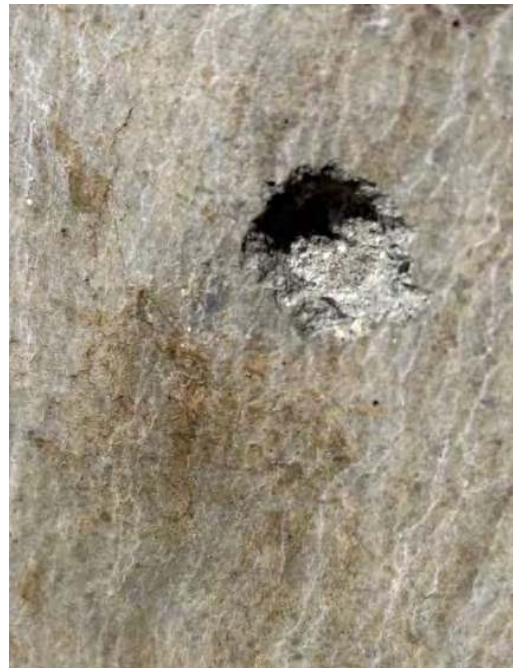
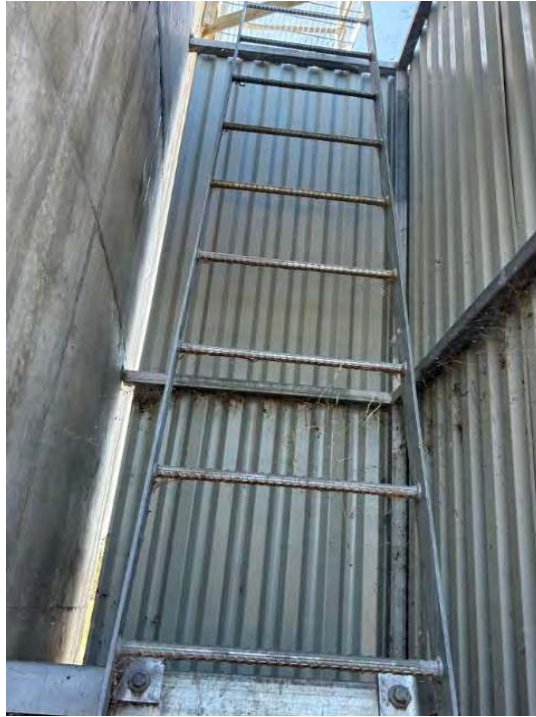
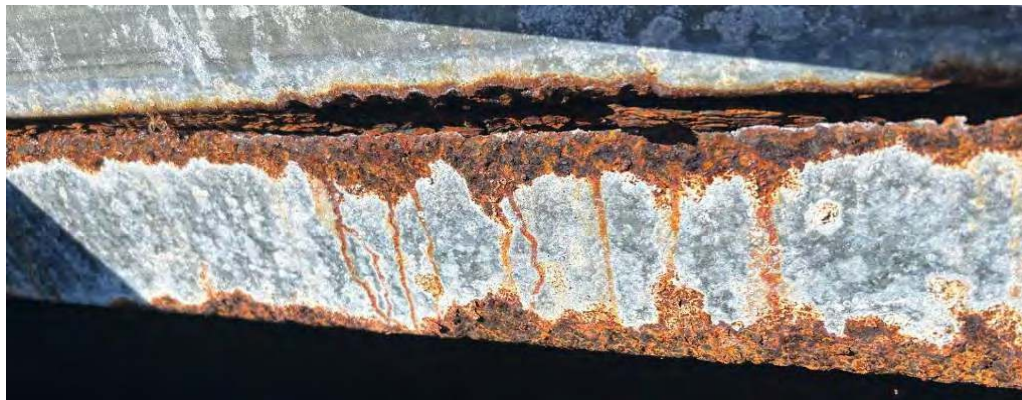
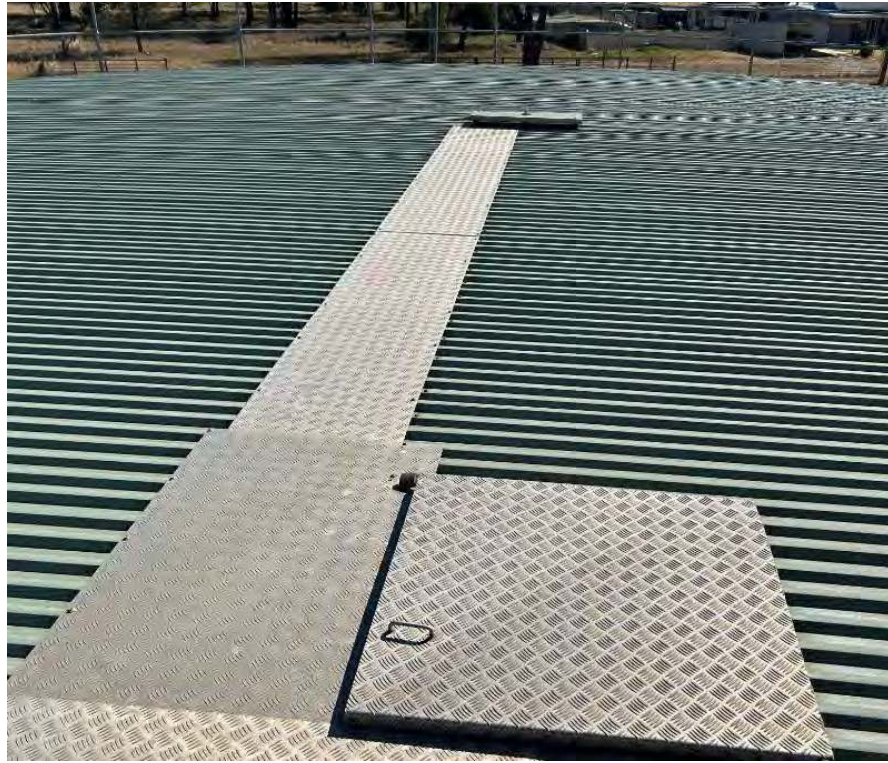
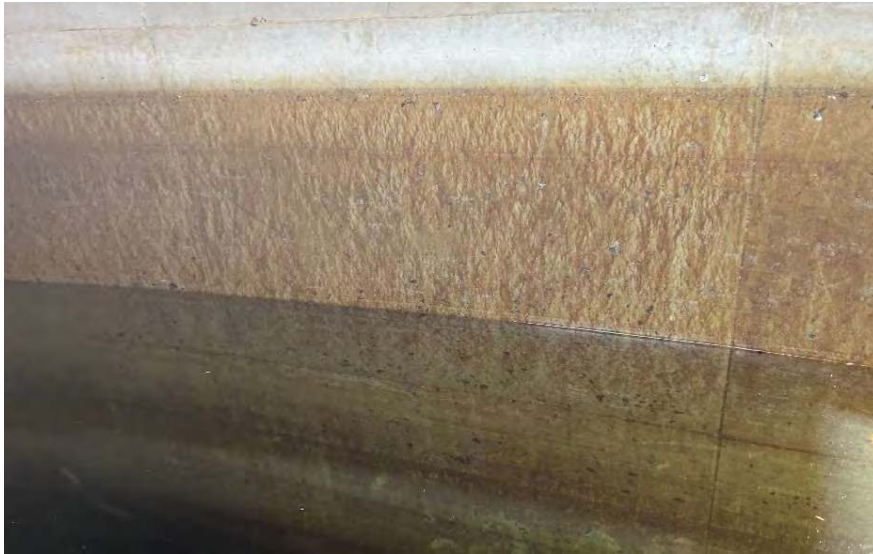
SITE PHOTOS

SL NO	ITEM DESCRIPTION	DEFECTS	GRADING KEY	REMARKS
1	External Wall - General		2 - Good	
2	External Wall - Concrete/Reo	Construction Joint failed	4 - Poor	
3	External Access Ladder		2 - Good	
4	Metal Roof		2 - Good	
5	Roof Access Hatch	Slight Rust present	3 - Fair	
6	External Valves & Pipework		2 - Good	
7	Internal Wall - General		2 - Good	
8	Internal Wall - Concrete/Reo		2 - Good	
9	Internal Wall & Floor Joints		6 N/A	Unable to see Reservoir was full of water
10	Internal Access Ladder		6 - N/A	Unable to see Reservoir was full of water
11	Internal Pipework		6 - N/A	Unable to see Reservoir was full of water
12	Floor Inlet & Scour point		6 - N/A	Unable to see Reservoir was full of water

Repairs noted as below

- Construction Joint failed and needs to be repaired
